# Confidential Mold Assessment

LOCATED AT:  
123 Main  
Anytown, New York 12205

INSPECTED ON:  
Monday, February 02, 2026

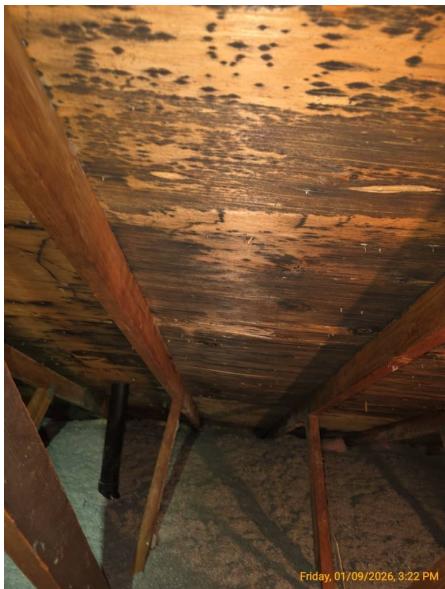
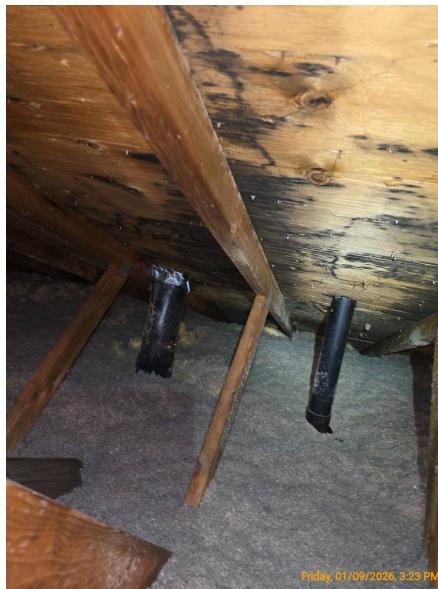
Mold was noted on sheathing and rafters in the attic.

Total area to remediate was about 900 square feet.

The underlying cause of the mold was likely due to insufficient ventilation. Recommend ventilation be improved to prevent mold from returning after remediation.

It was noted that one or more bathroom fans vented to the attic. Bathroom fans must vent to a gable wall or through the roof correctly prior to clearance.
