Confidential Inspection Report

LOCATED AT:
123 Main Street
Somewhere, New York 12018

INSPECTED ON:
Thursday, October 30, 2025

Carey Home Inspection

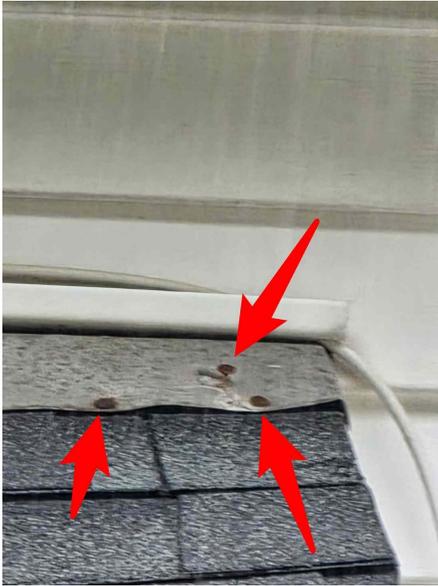
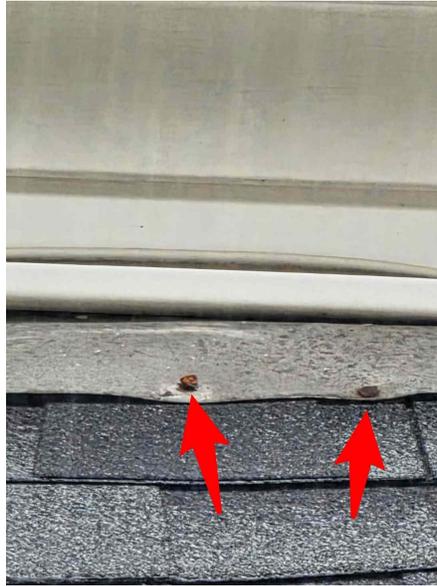
MIN Noted exposed nails. This can allow for moisture infiltration.

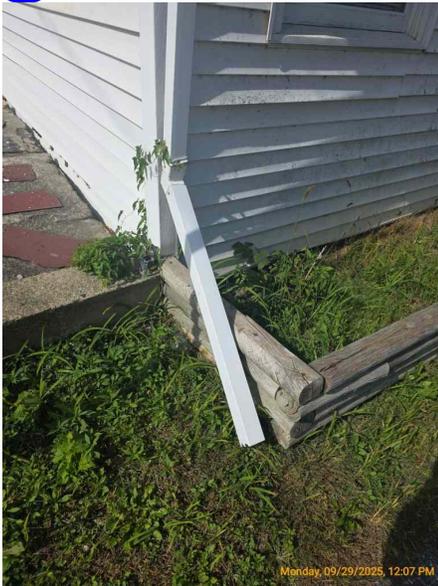
UPGR Gutters had extensions, but they were not long enough to get water away from the foundation.

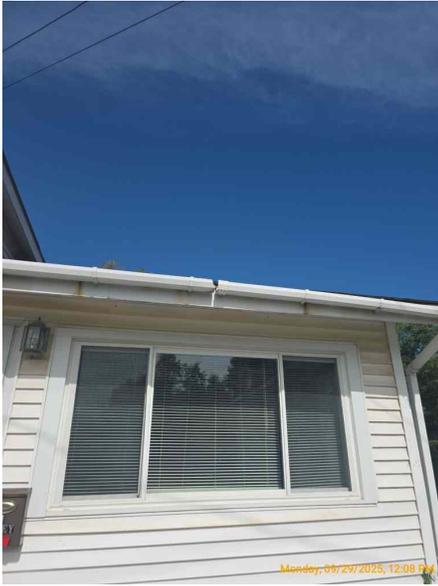
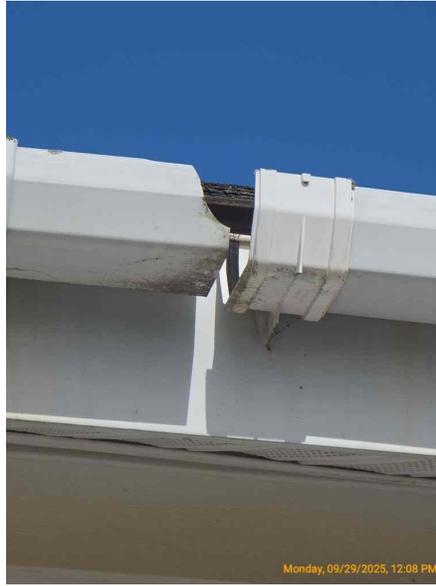
MIN Noted damaged gutter. This could compromise the function of the gutters.

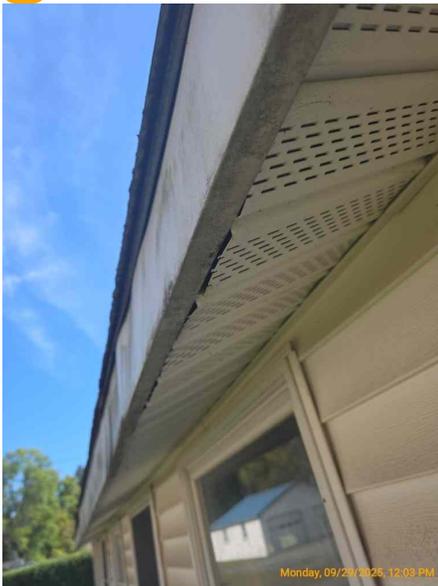
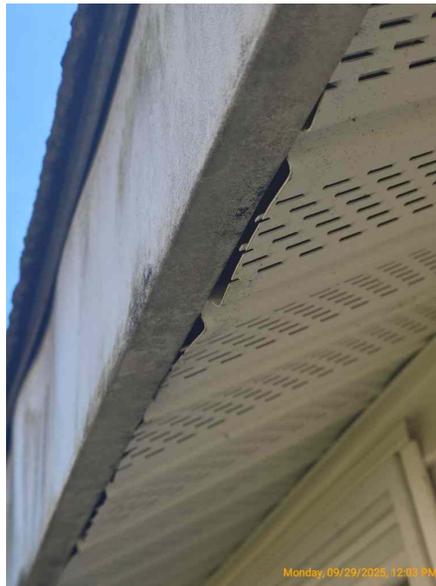
MIN Noted gaps in trim. This can allow for moisture or pest infiltration.

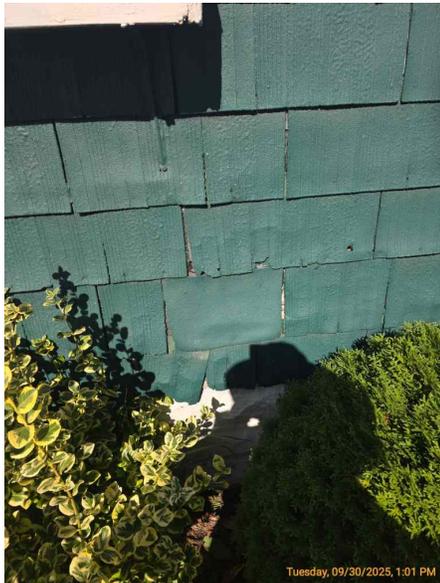
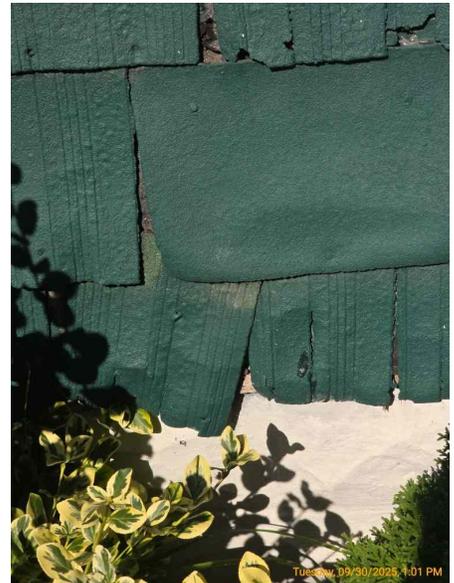
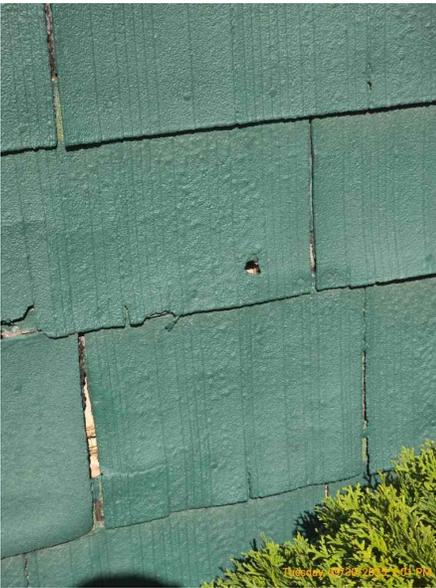
FIX Noted missing, loose, or otherwise damaged siding and trim at the time of inspection. This can allow for moisture infiltration.

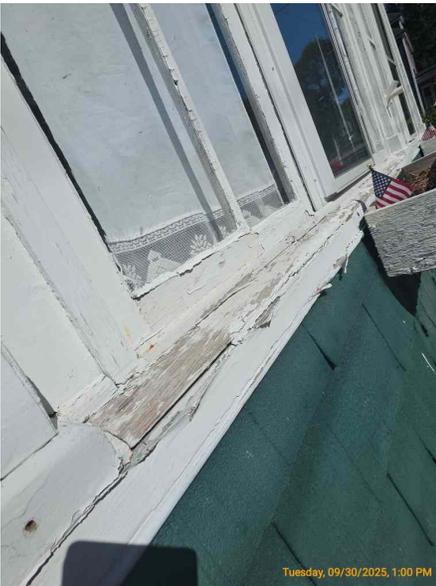
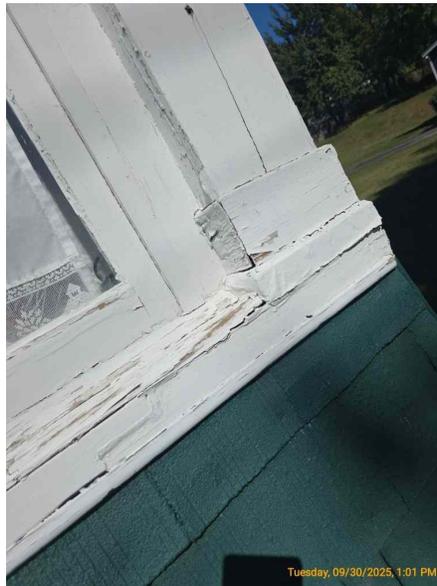
FIX Noted areas of exposed wood in need of paint at the time of inspection. Exposed wood is more prone to deterioration.

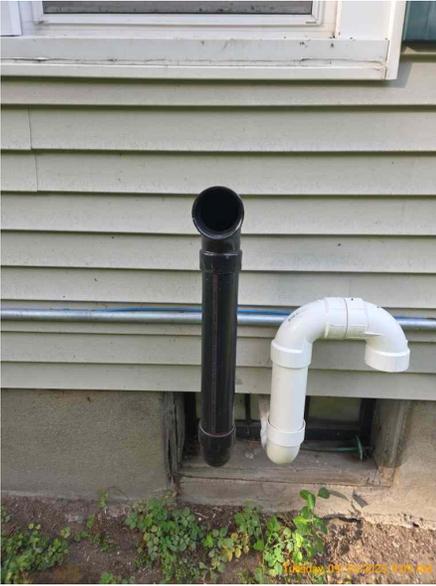
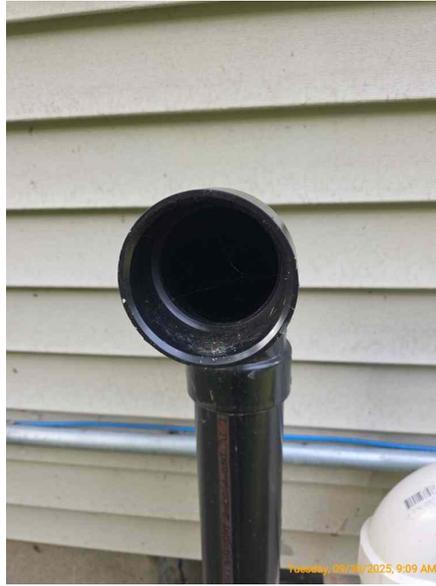
MIN Exterior wall penetration is missing a screen. This could allow for pest infiltration.

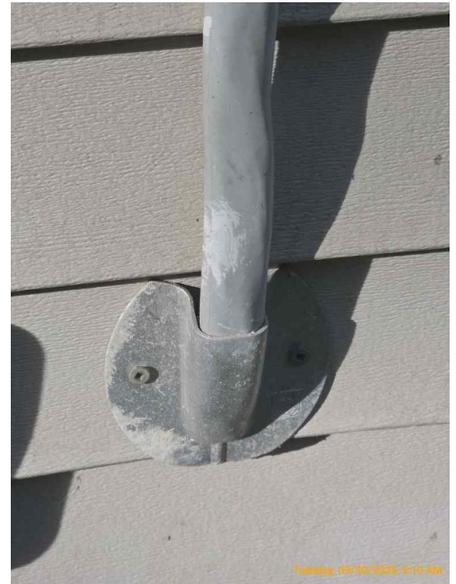
FIX Noted meter caulking was missing or deteriorated. This can allow for water infiltration to the electrical panel.

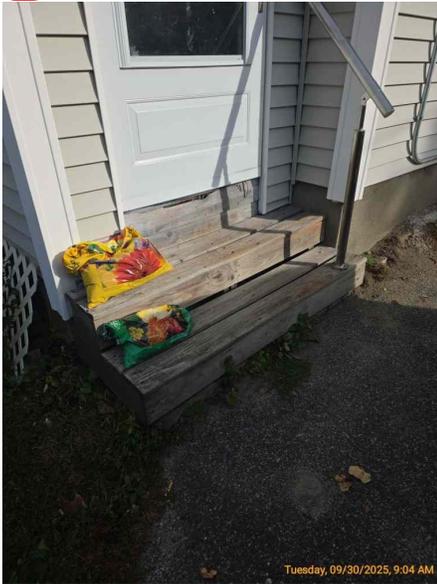
SFTY Noted steps were out of level. This is a safety hazard.

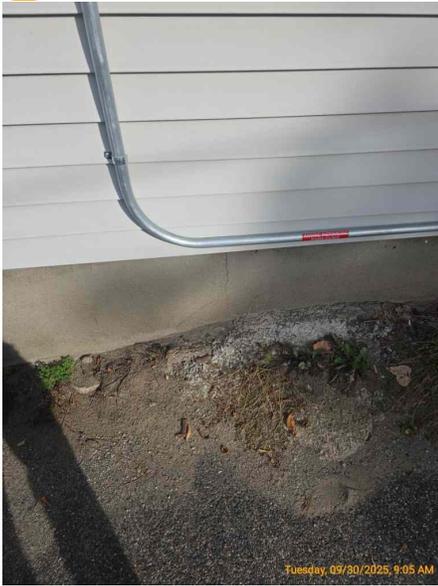
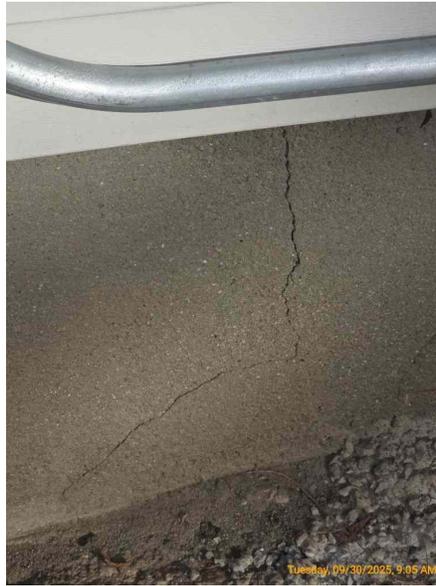
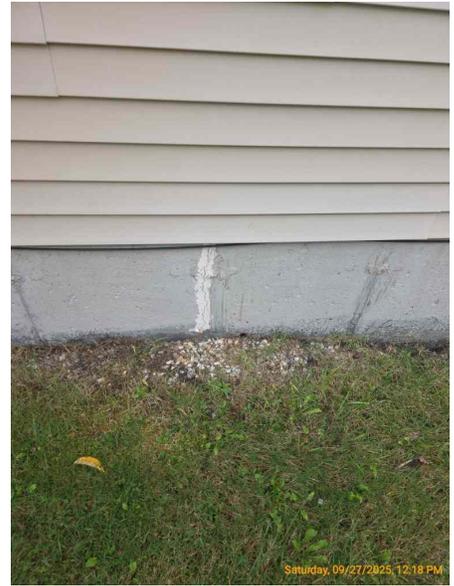
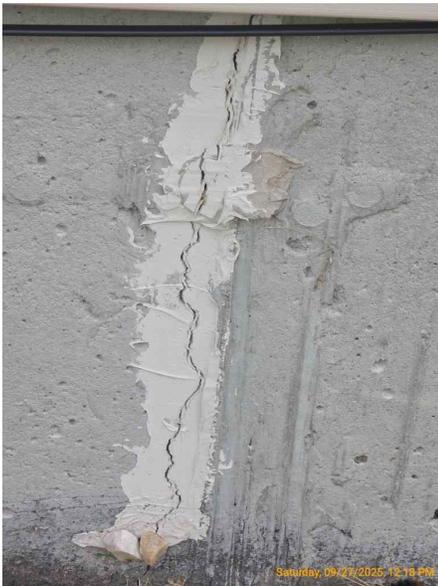
MIN Noted cracks in exterior foundation walls. This could allow for moisture infiltration.

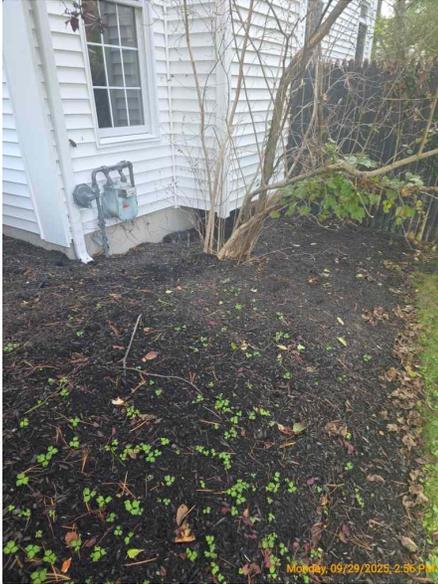
FIX Perimeter grading sloped towards the building. This can lead to pooling of water around the foundation.

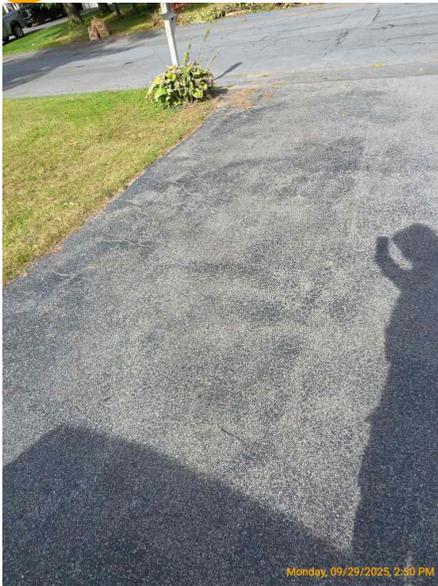
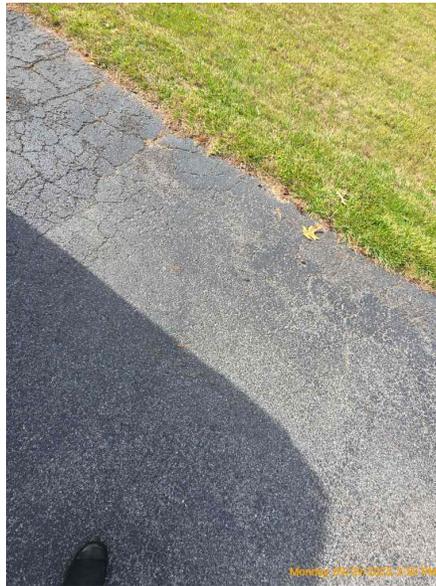
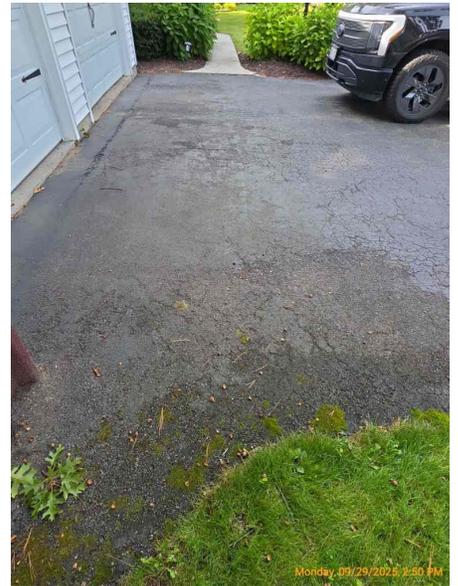
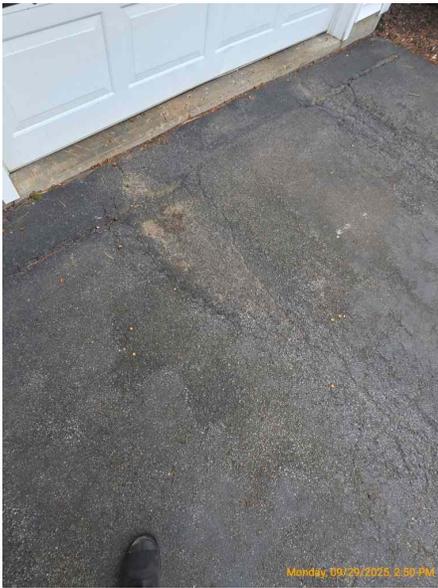
MIN Noted areas of driveway are in need of repair. This could lead to further deterioration if left as is.

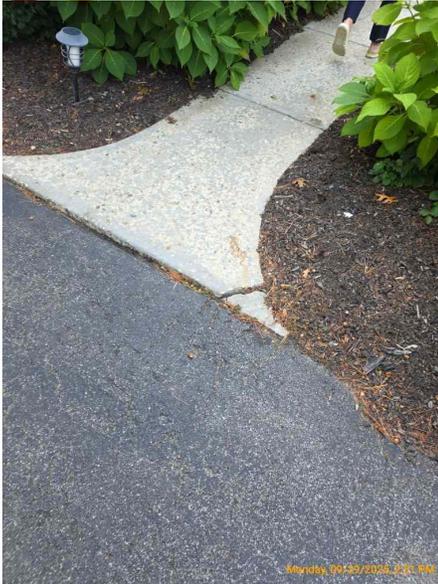
SFTY **MIN** Noted areas of walkway were displaced. This is a safety hazard.

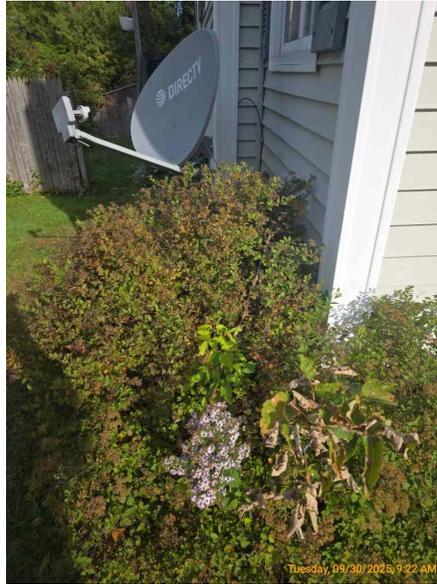
MAIN Noted shrubs in contact with siding. This can lead to premature aging of the siding.

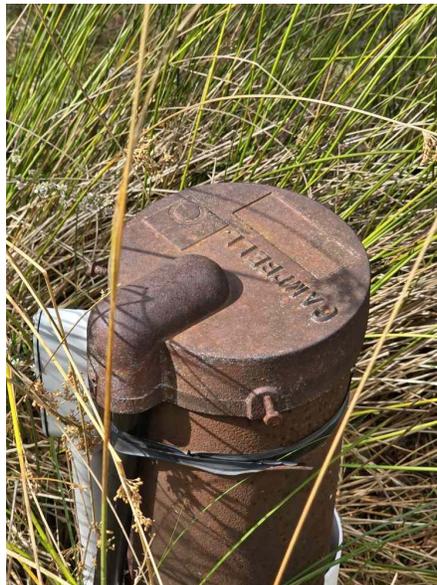
SFTY Noted the well is not fitted with a sanitary cap. This could allow insects, surface water, and other contaminants to enter the well

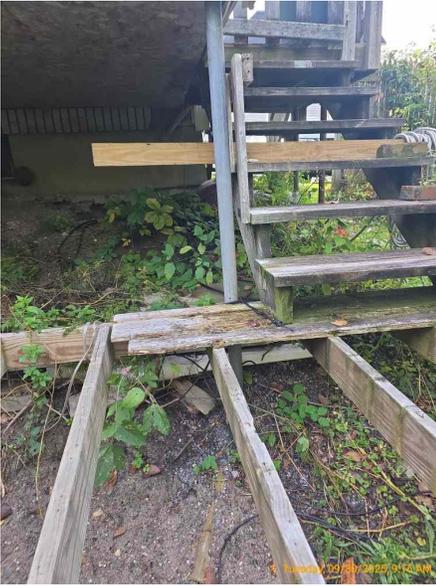
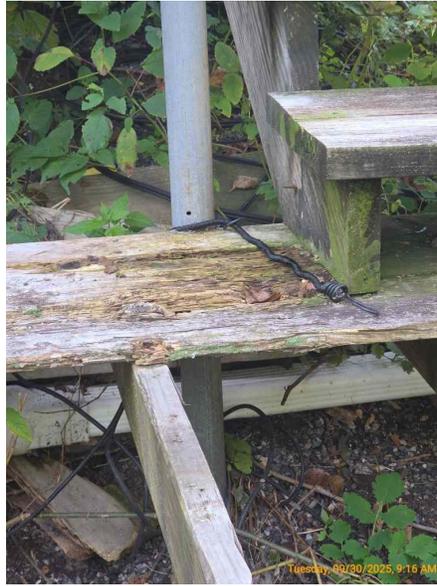
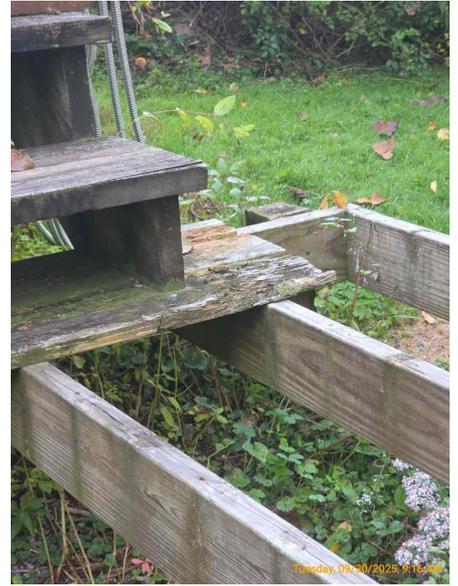
FIX Noted areas of rot at the time of inspection. If left as is further deterioration could occur.

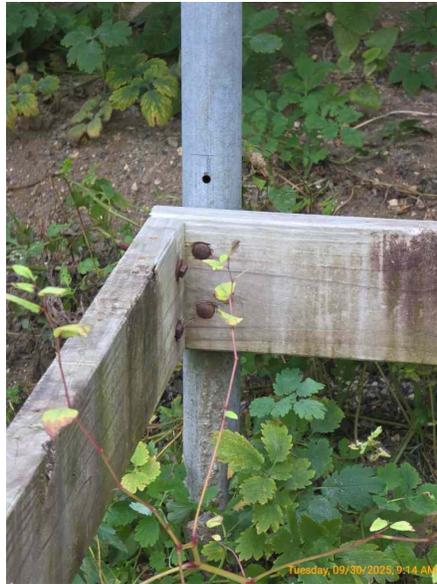
FIX Noted non-standard deck framing. This could compromise the structural integrity of the framing.

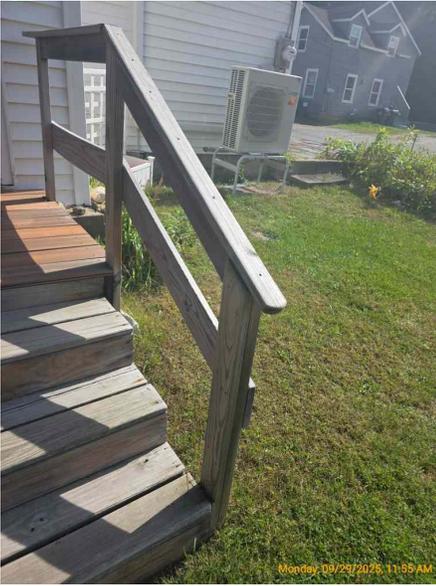
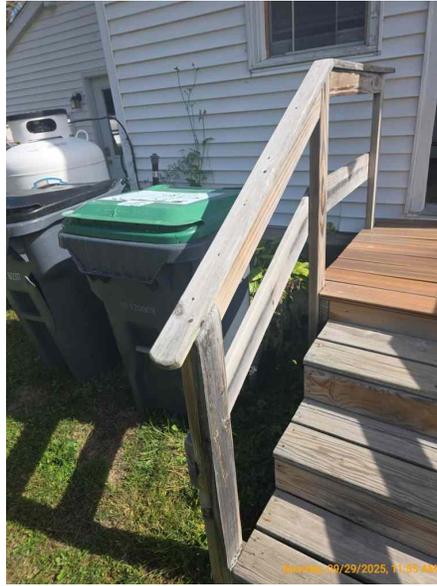
SFTY Handrail was non-standard. This is a safety hazard.

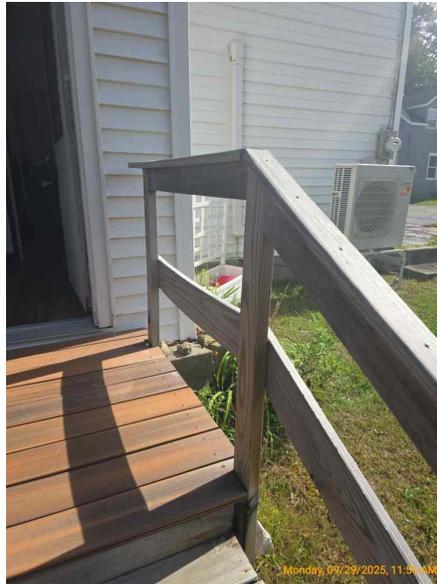
SFTY Guardrail construction is non-standard. This is a safety hazard.

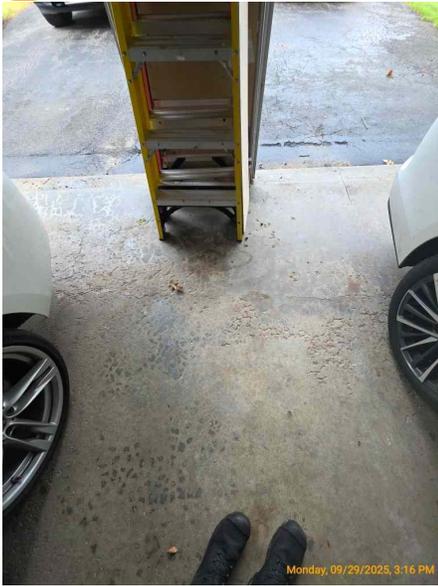
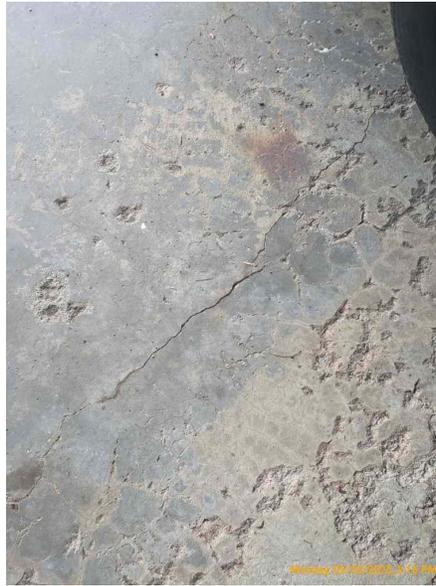
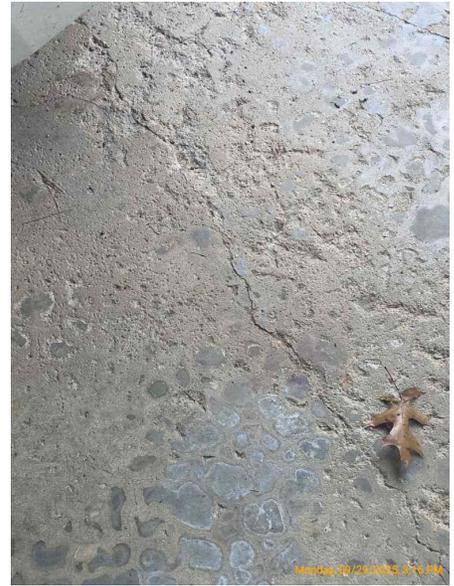
MIN Noted one or more cracks in the floor. This can allow for moisture infiltration.

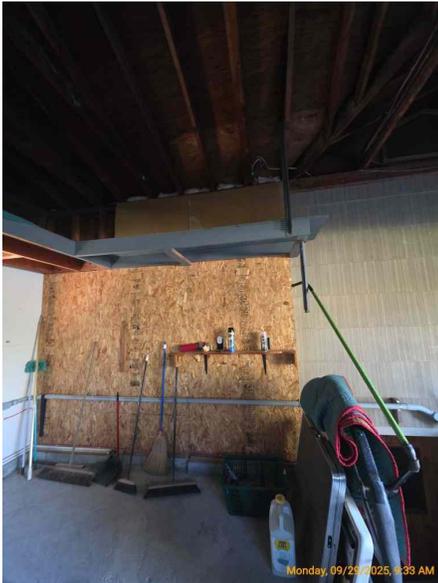
SFTY Noted attached garage was not sealed with 5/8 drywall, tape, and spackle creating a firebreak between the house and garage. Garages typically contain flammable material and should be constructed to reduce the spread of a fire should one occur.

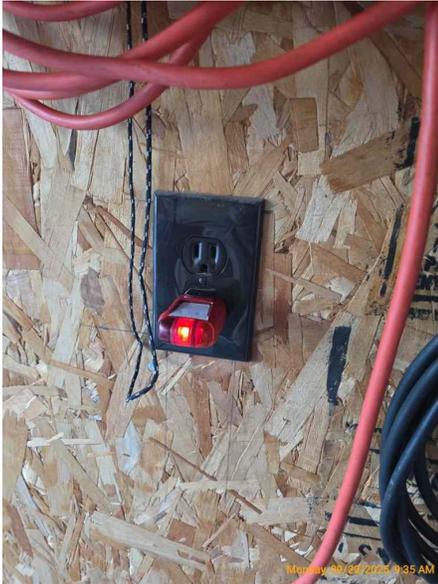
SFTY Outlet appeared to have no ground fault circuit interrupter (GFCI) protection. Garages are susceptible to water and outlets should be protected by GFCI.

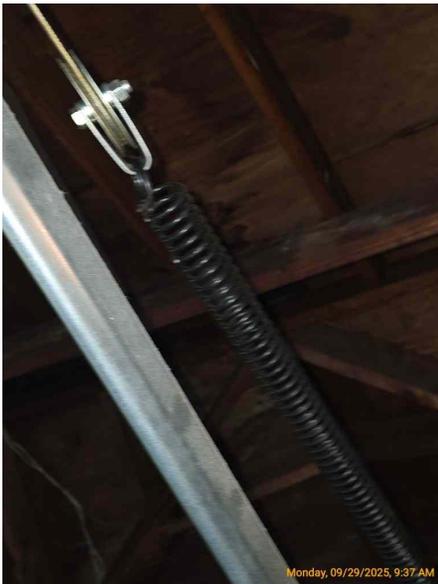
SFTY No safety cable noted on garage door springs. These cables prevent the springs from breaking free in the event of failure. This is a safety hazard.

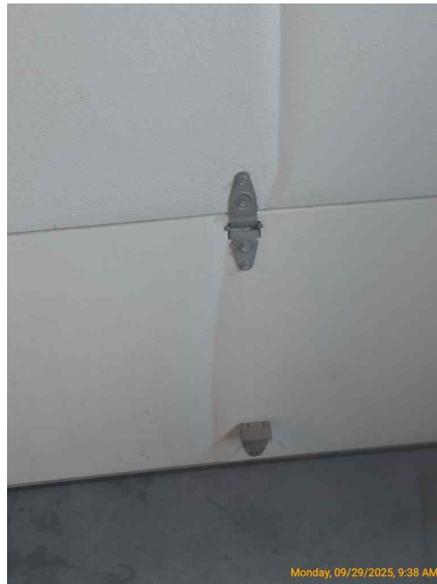
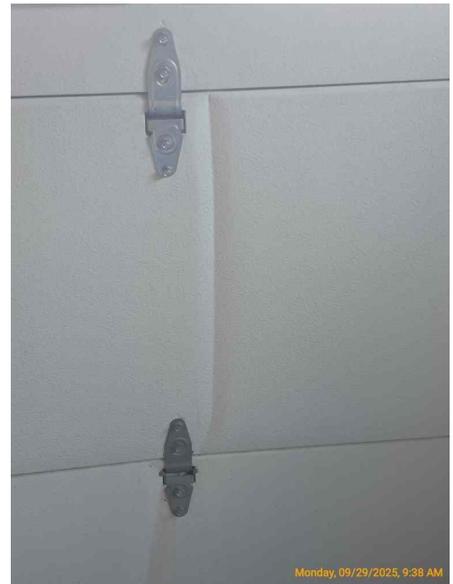
FIX Noted the overhead door was damaged. This could compromise the function of the door.

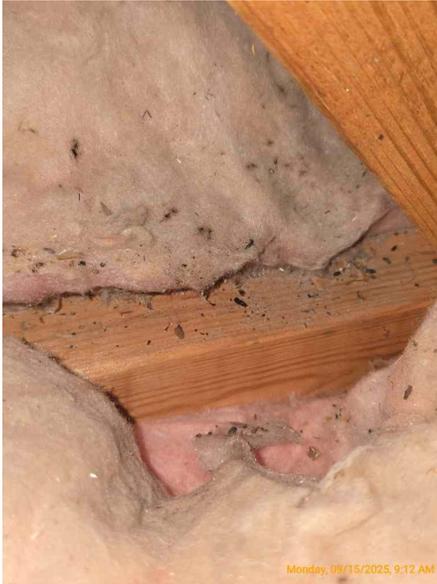
FIX Rodents have been active in the attic in the past. We recommend that bait or traps be set and monitored. The advice and services of a licensed exterminator is recommended. Removal of pest droppings is recommended.

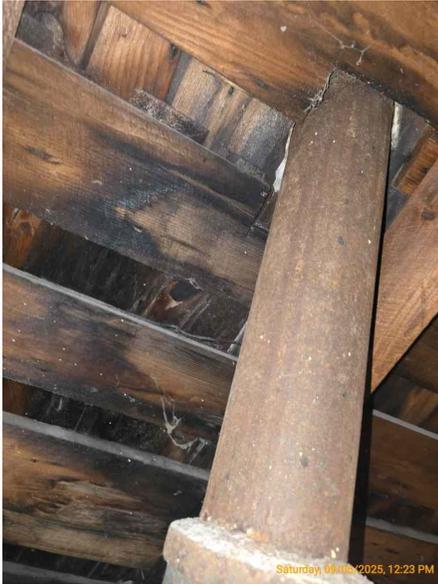
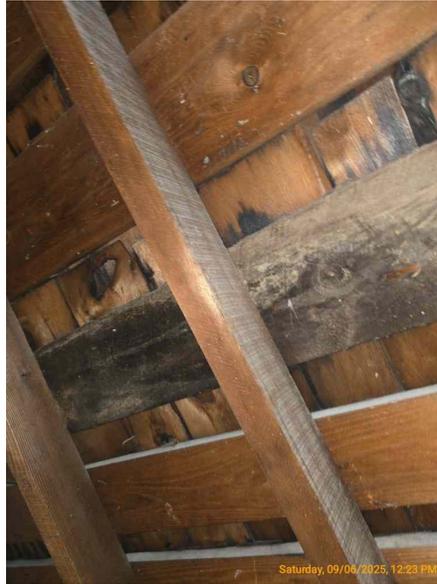
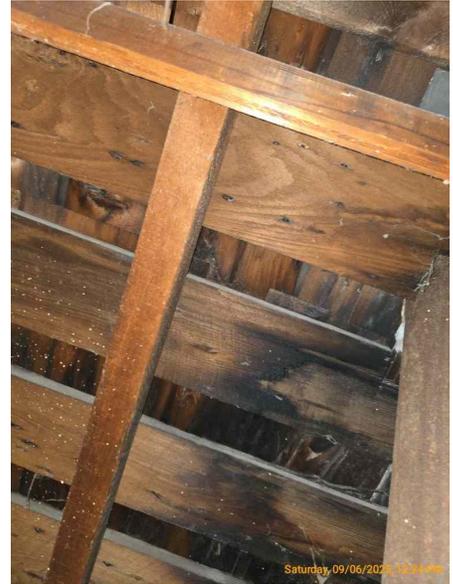
MON There were water stains on the underside of the sheathing and the rafters. These are indications of old leaks. No current leakage was noted at the time of the inspection. Since attic leaks can occur during various weather conditions it is recommended to monitor these stains and repair if needed.

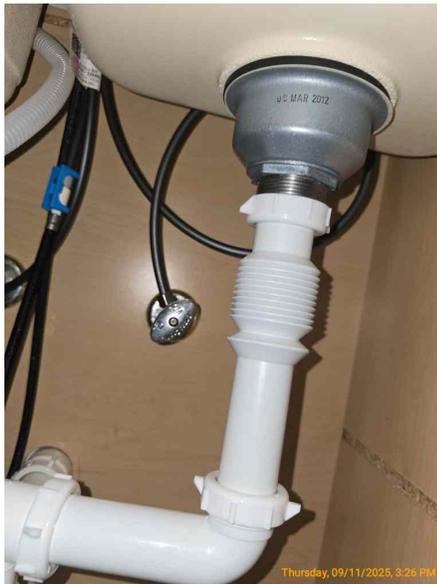
UPGR A flexible rubber or plastic fitting was used in the drain trap and was nonconforming. The system was functional at the time of inspection, modification would be considered optional.

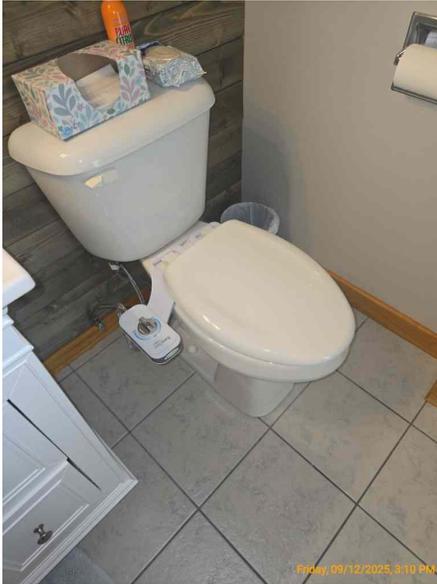
FIX The toilet was loose at the floor. While no damage was evident, this condition should be taken care of so that leakage does not develop and cause damage. We recommend that the toilet be removed and rebolted with a new wax seal.

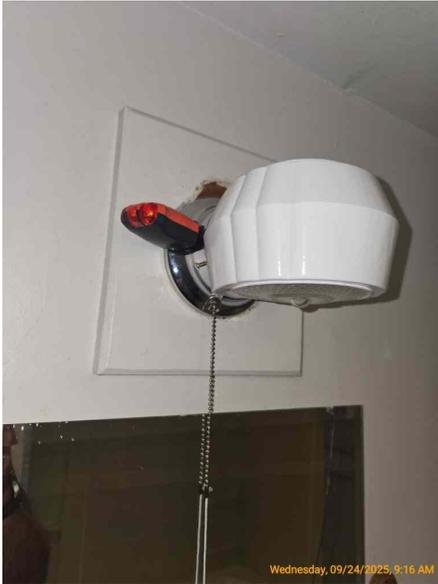
SFTY There was no GFCI (ground fault circuit interrupter) protection noted for this bathroom. For an increased margin of safety, we recommend the installation of a GFCI receptacle.

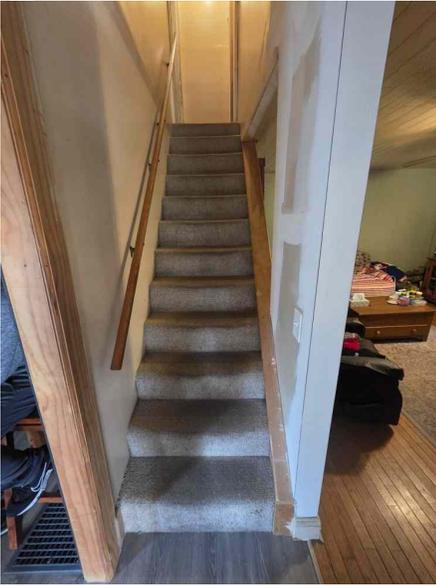
SFTY Noted steps were out of level. This is a safety hazard.

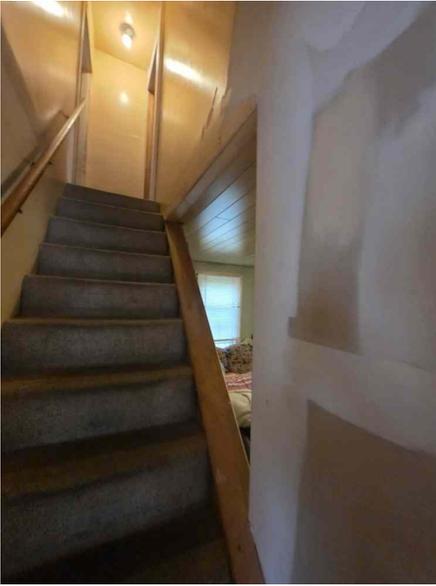
SFTY Noted no handrail or guardrail on the open side of the stairs. This is a safety hazard.

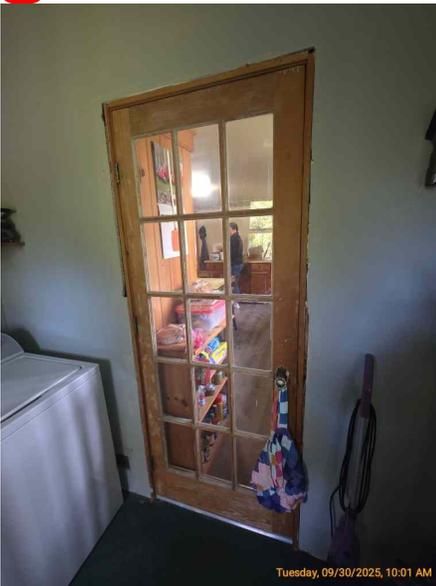
SFTY Noted missing safety glass at the time of inspection. This is a safety hazard.

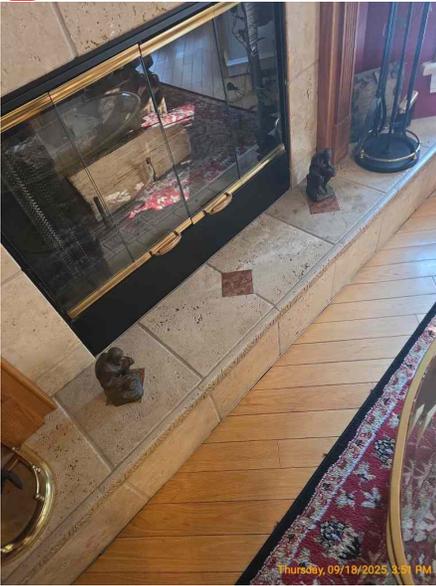
SFTY Noted flammable material within 18 inches of the firebox.

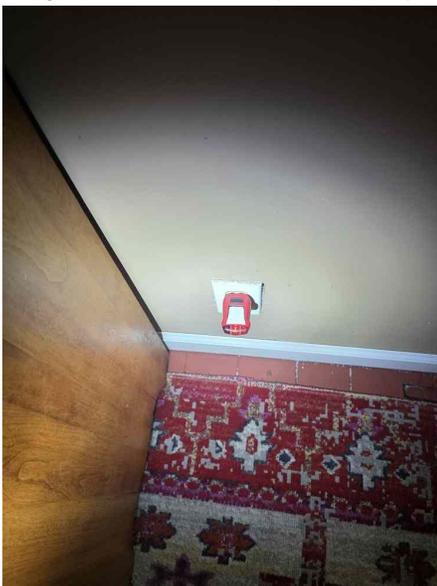
SFTY Noted open ground outlet. This could be a safety hazard when this outlet is used with a three pronged plug. In the even stray electricity is discharged to the unconnected ground electric shock can occur.

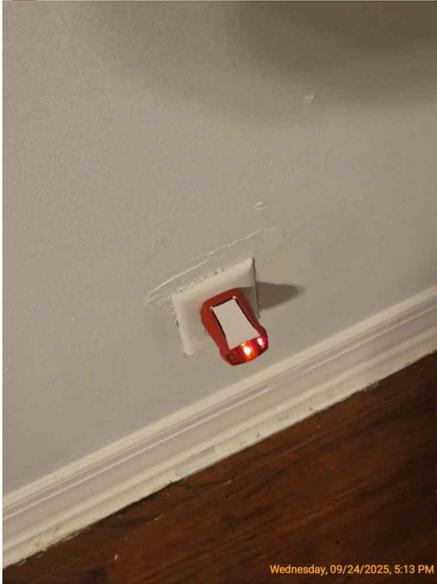
SFTY Outlet has a hot/neutral reverse. This is a safety hazard.

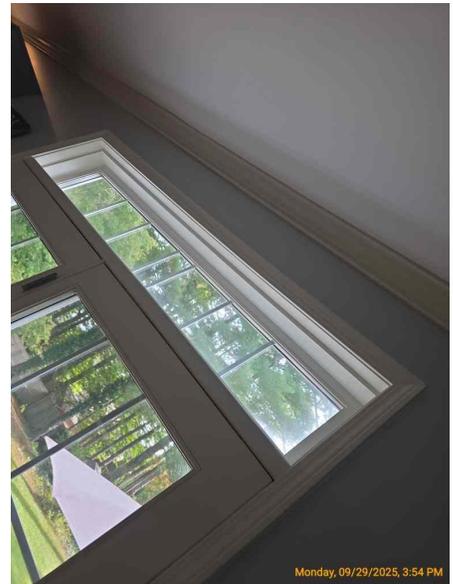
FIX Window appears to have lost its thermal insulation.

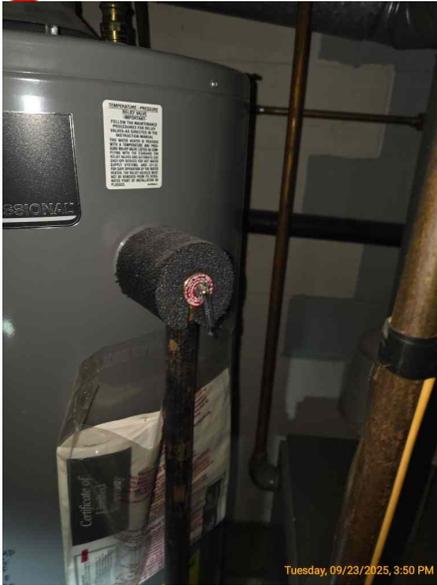
SFTY Noted the safety extension is not within 6 inches of the floor. This is a safety hazard.

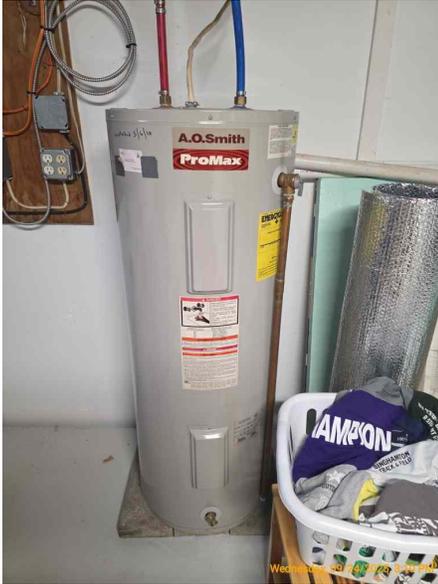
MIN Noted plumbing supply connections to the hot water heater are PEX (cross-linked polyethylene) within 18 inches of the tank. PEX is not an acceptable connection material.

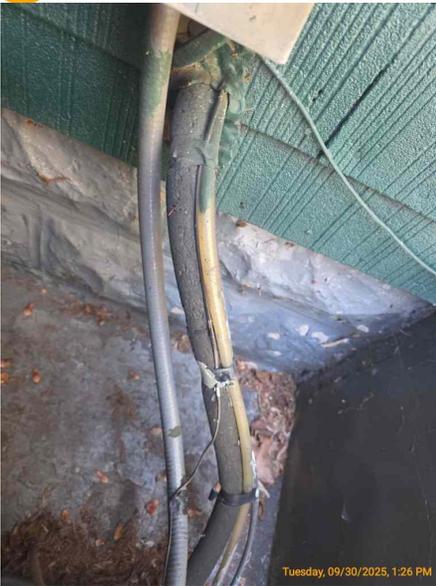
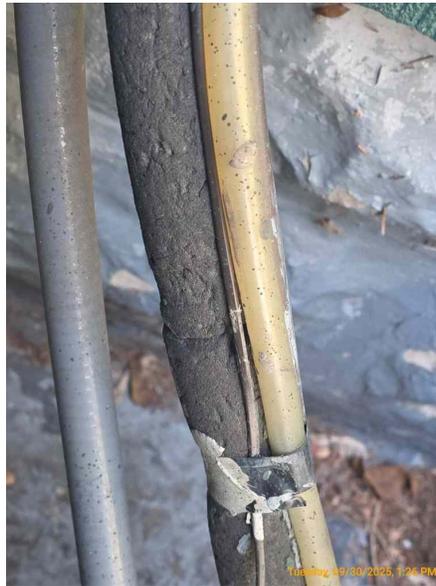
MIN Refrigerant line insulation is deteriorated.

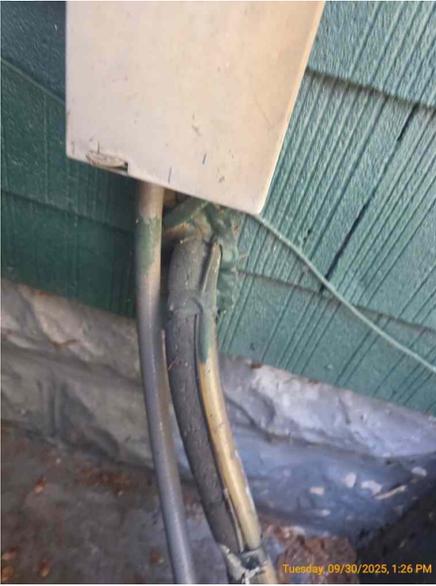
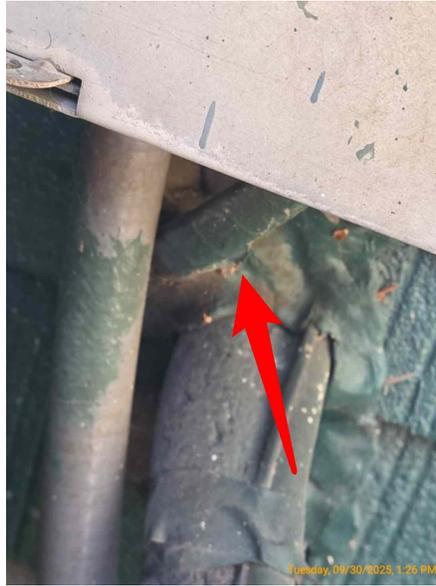
SFTY Electrical wiring is installed in such a manner that it is prone to damage.

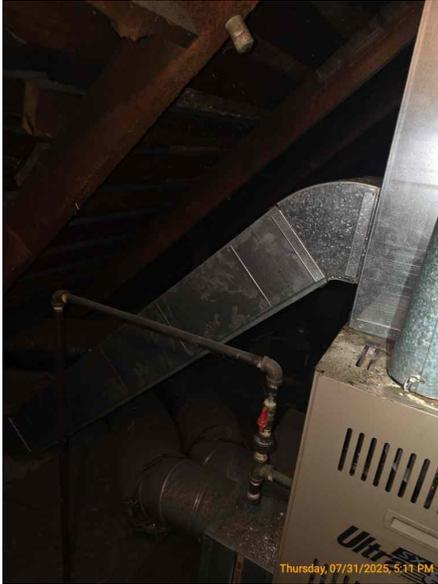
UPGR The ducts are uninsulated. This will result in energy inefficiency and unnecessarily high energy costs. As an upgrade, we recommend insulating the ducts in accordance with present standards.

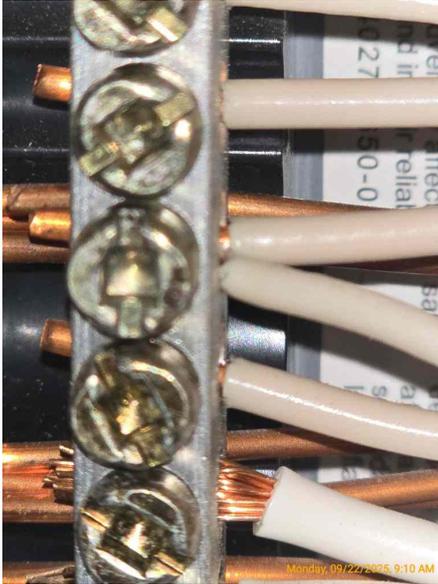
MIN One or more neutrals are double tapped, where 2 or more white wires are clamped in one terminal or a white and ground wire are in the same terminal. This method of wiring is common but no longer acceptable. It is not acceptable to have the neutral connection and the ground connection under the same screw since disconnecting the neutral would also disconnect the ground. The intent is that the ground, including the grounding electrode connection, always remain solidly connected. Recommend having a licensed electrician evaluate and repair.

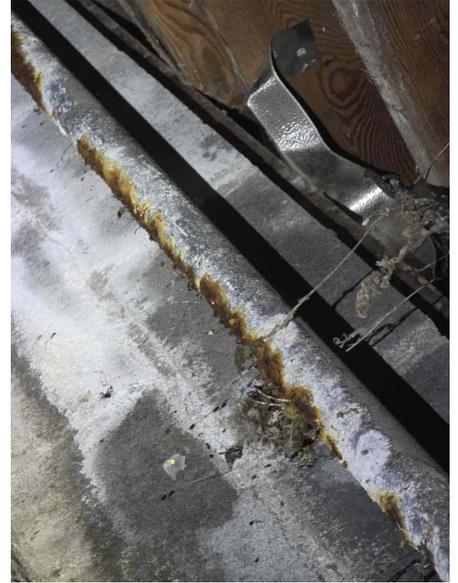
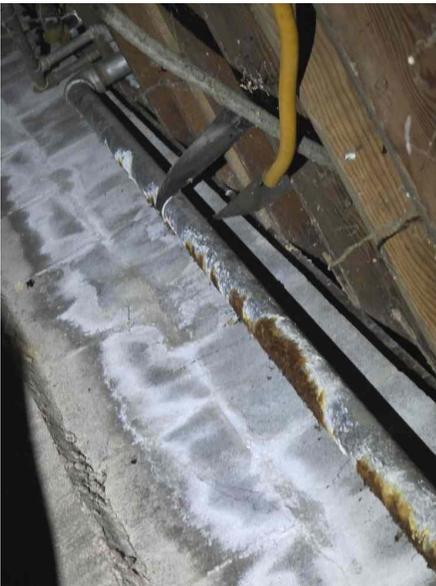
FIX Noted active leak in drain and/or waste pipes or fittings at the time of inspection.

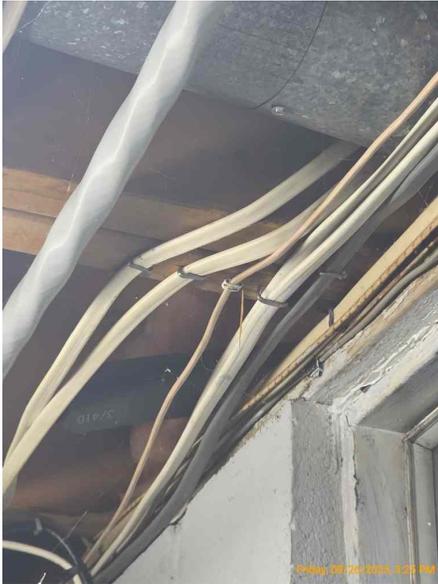
SFTY Electrical wiring was installed incorrectly. Non-metallic wiring should be installed in such a manner that it is not prone to damage. This is a safety hazard.

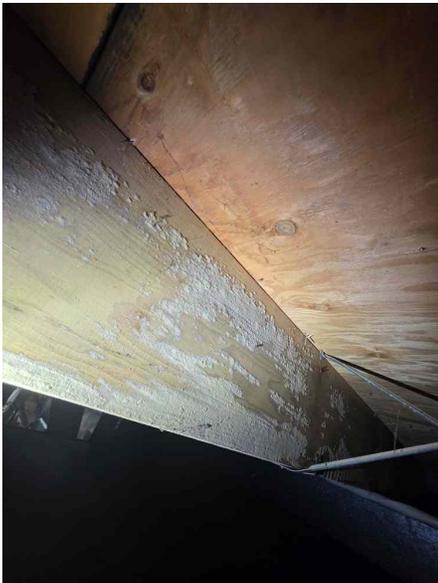
FIX Mold like substance noted in the basement. Mold is often a sign of insufficient ventilation and/or moisture presence. Recommend contacting a mold remediation company to remove the mold and correct the underlying cause.
