Confidential Inspection Report

LOCATED AT:
123 Main Street
Somewhere, New York 12018

INSPECTED ON:
Thursday, October 30, 2025

Carey Home Inspection

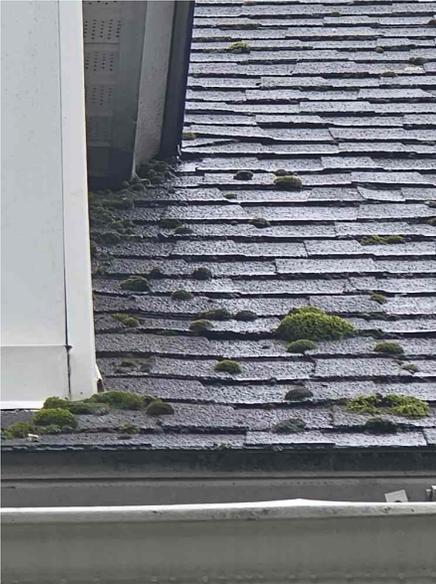
MIN Noted moss on shingles. This can lead to premature aging of the roof covering and to moisture leaching beneath the shingles.

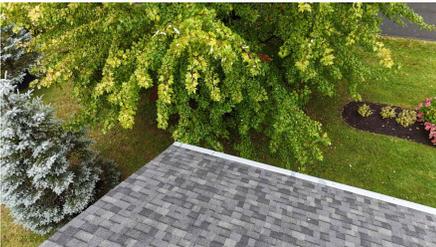
MIN Trees are overhanging and within 10 ft of the roof surface. This could allow for moss and debris build up on the roof, or damage from abrasion.

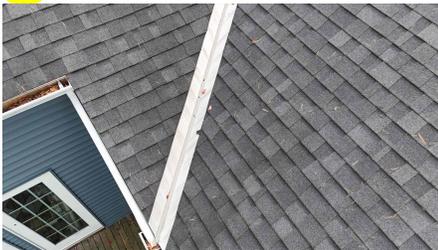
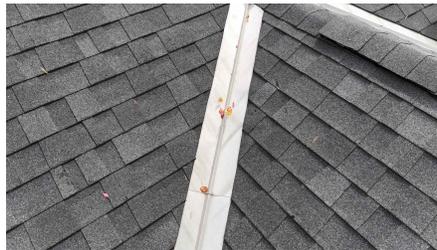
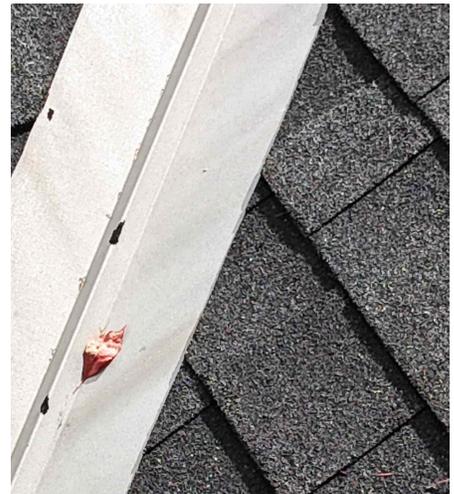
FIX Valley flashings appeared to be installed incorrectly. This could allow for moisture infiltration.

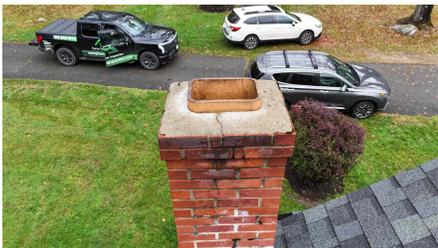
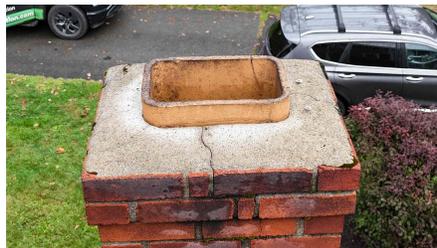
FIX Noted chimney did not have a rain cap. This can allow rain to enter the chimney and cause premature aging of the flue and chimney.

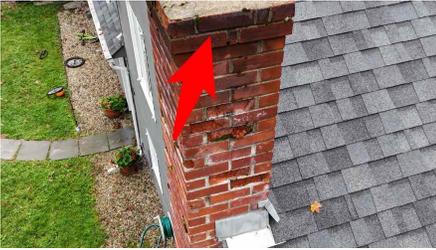
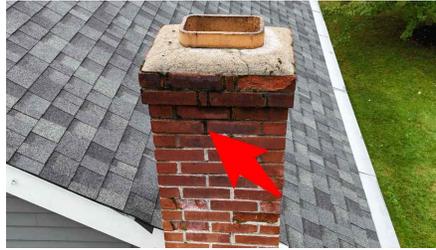
FIX Noted chimney was missing mortar in places. This may lead to moisture penetration of the chimney and eventually the roof.

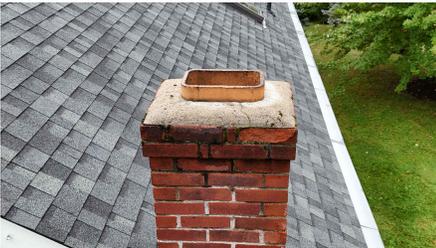
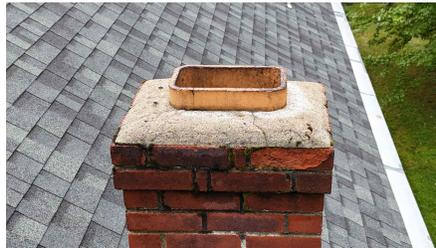
FIX Noted chimney crown did not extend 2 inches past the masonry. All masonry chimneys should be equipped with a crown that extends at least two inches past the masonry.

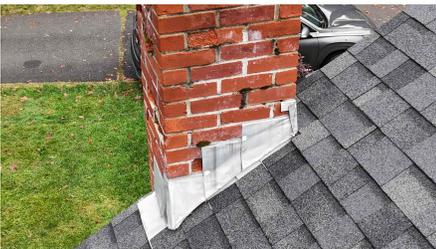
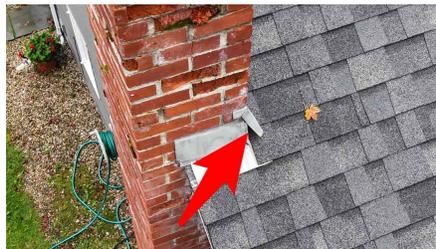
FIX Noted the chimney flashing was loose, deteriorated, or non-standard. This can allow for moisture infiltration.

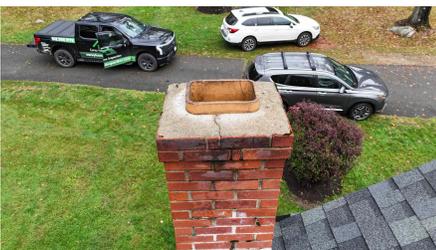
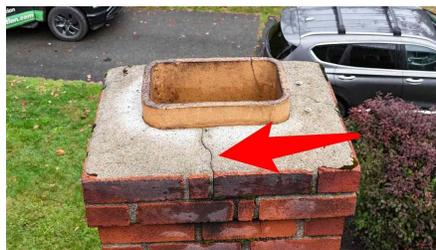
FIX Noted the chimney crown was cracked. This can allow for moisture infiltration and deterioration of the flue.

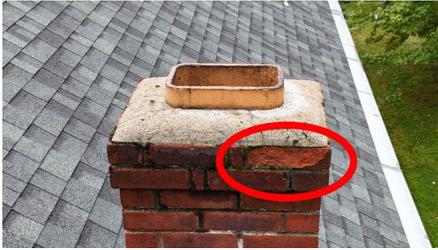
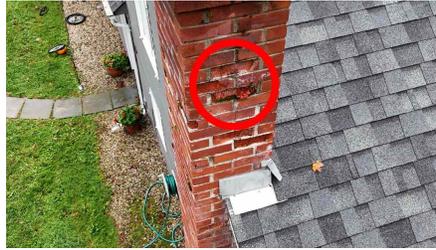
FIX Noted spalling on the chimney. Spalling is a result of water entering brick, concrete or natural stone and forcing the surface to peel, pop out or flake off.

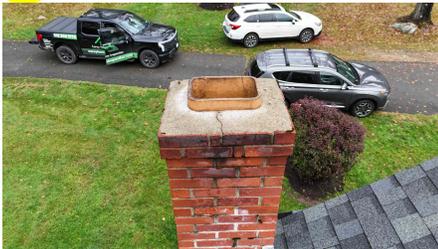
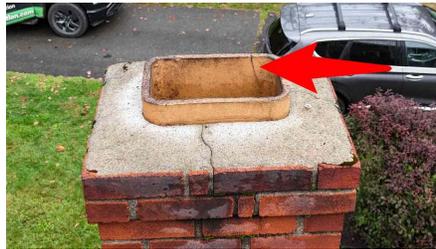
FIX Noted the flue is damaged. This could compromise the function of the chimney

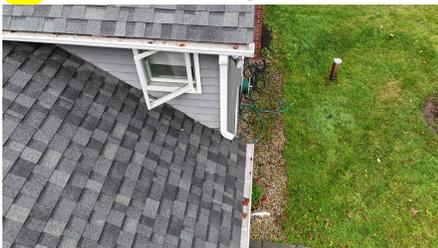
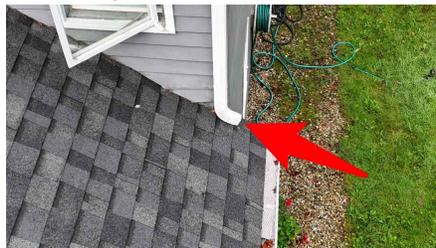
FIX Gutter discharges on to the roof covering. This could prematurely wear the roof covering.

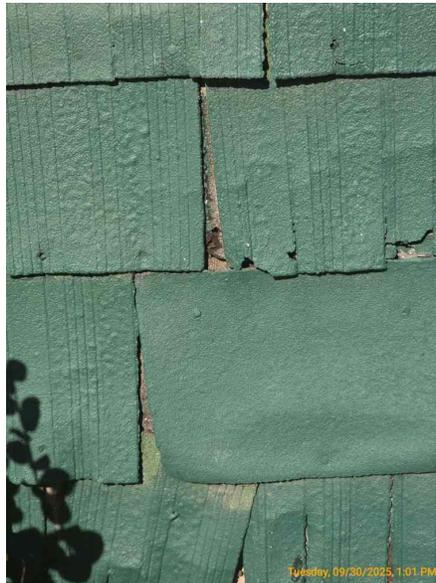
FIX Noted missing, loose, or otherwise damaged siding and trim at the time of inspection. This can allow for moisture infiltration.

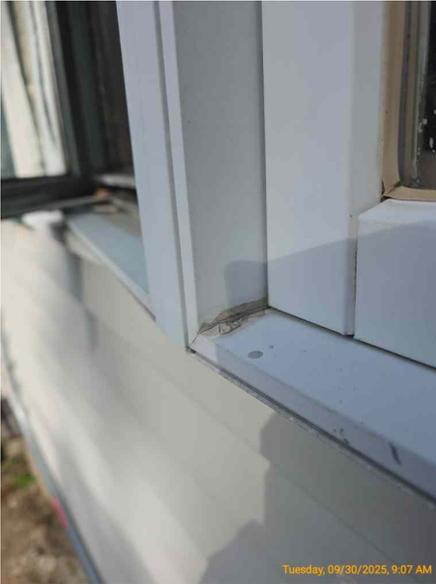
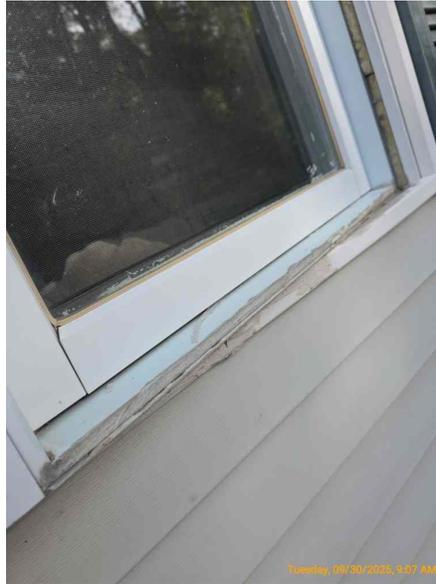
MIN Noted deteriorated or missing window caulk at the time of inspection. This can allow for moisture infiltration.

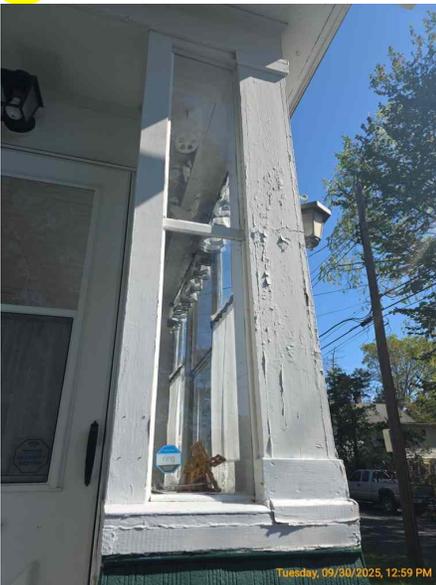
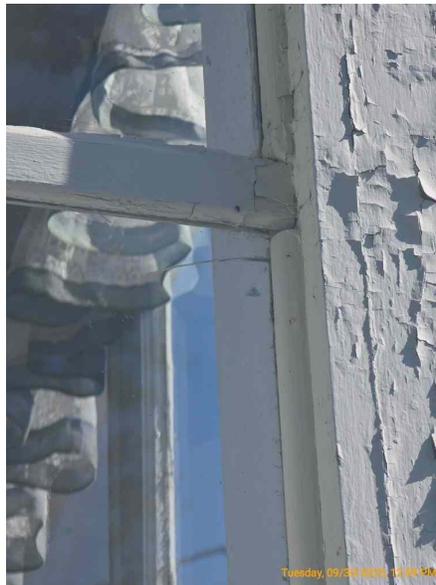
FIX Noted broken window. This can allow for moisture and pest infiltration.

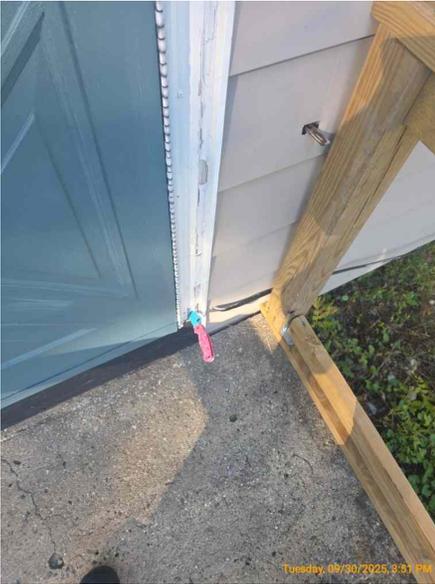
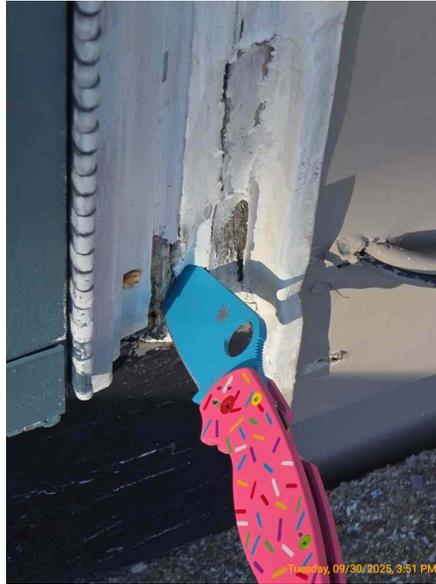
FIX Noted areas of rotted wood. If left as is further deterioration could occur.

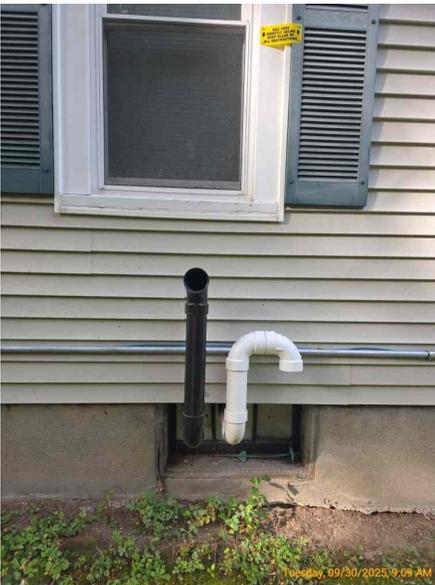
SFTY Noted high efficiency piping discharged under a window. This can allow for exhaust fumes to reenter the house through the window.

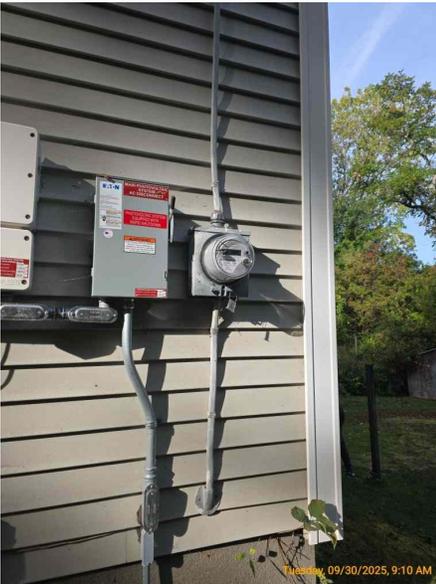
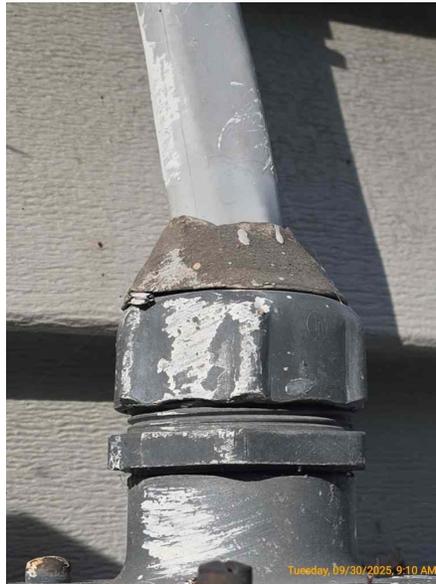
FIX Noted meter caulking was missing or deteriorated. This can allow for water infiltration to the electrical panel.

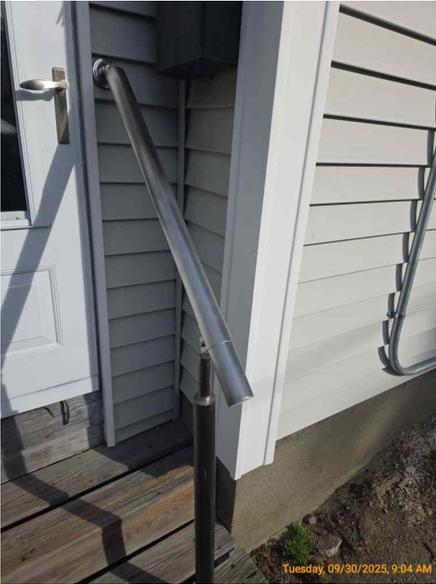
SFTY Handrail was non-standard. This is a safety hazard.

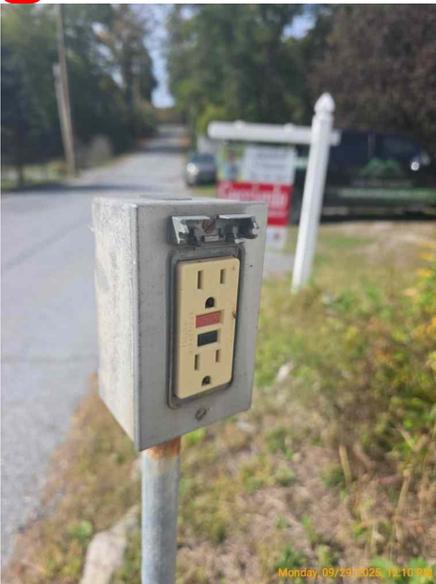
SFTY GFCI outlet failed to trip when tested. This is a safety hazard.

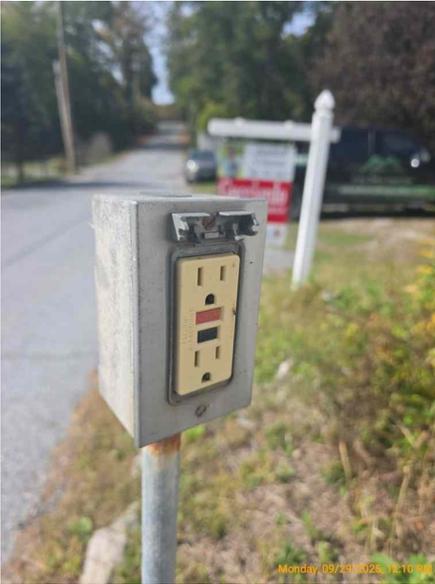
SFTY Outlet is missing a cover. This is a safety hazard.

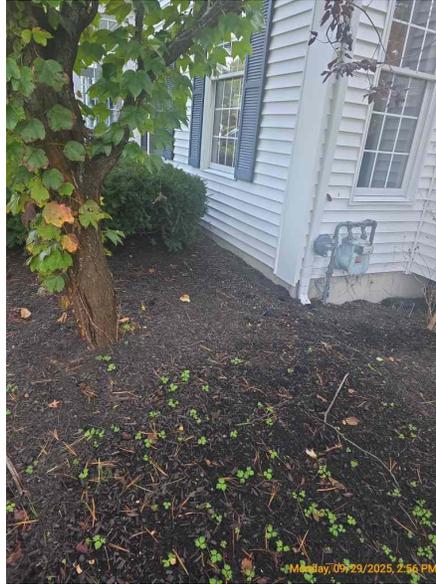
FIX Perimeter grading sloped towards the building. This can lead to pooling of water around the foundation.

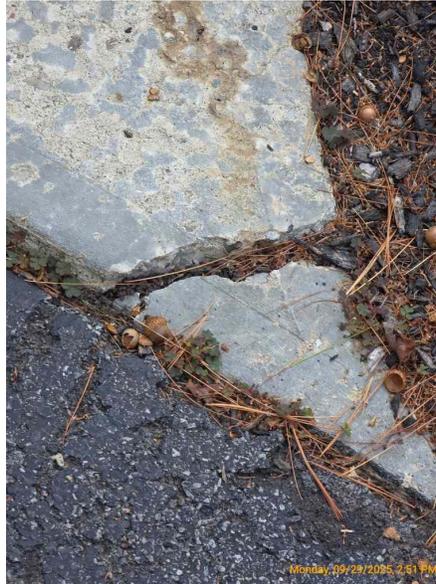
SFTY **MIN** Noted areas of walkway were displaced. This is a safety hazard.

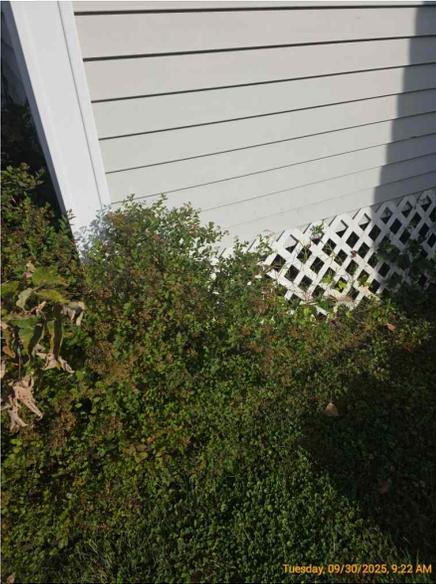
MAIN Noted shrubs in contact with siding. This can lead to premature aging of the siding.

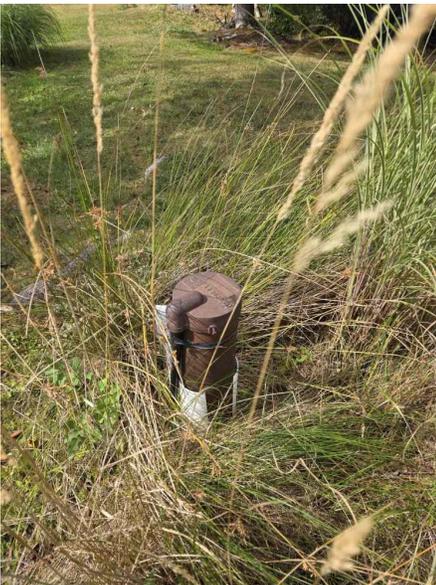
SFTY Noted the well is not fitted with a sanitary cap. This could allow insects, surface water, and other contaminants to enter the well

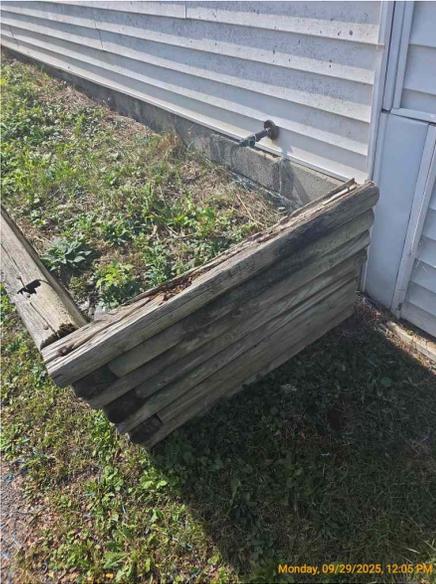
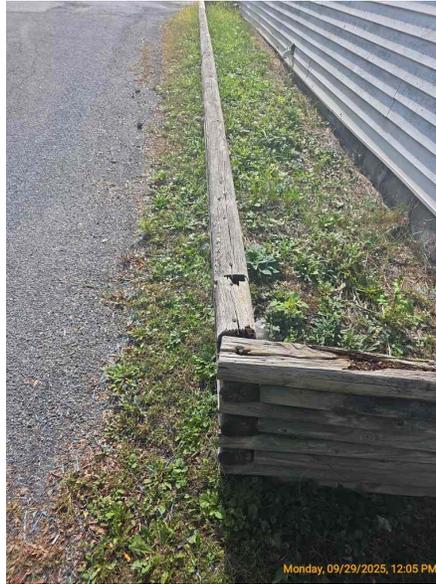
FIX Retaining walls were displaced and deteriorated.

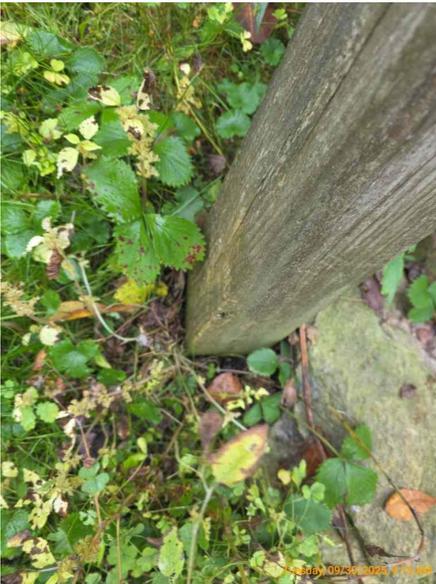
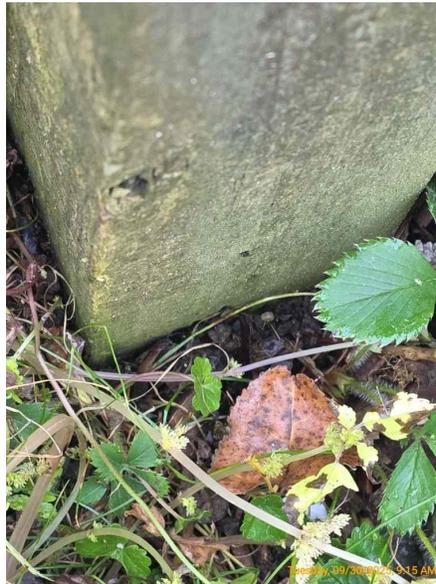
FIX Deck support posts did not appear to have proper footers. This could effect the structural integrity of the deck.

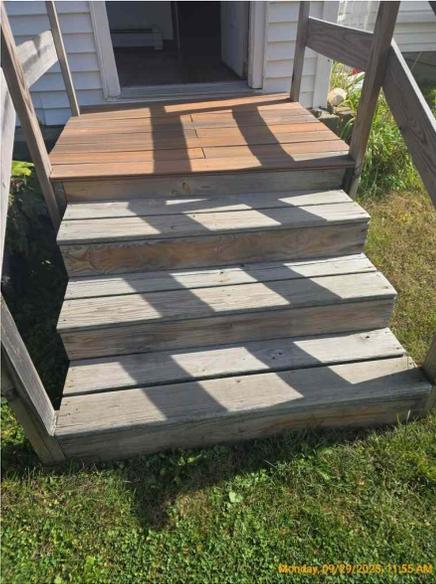
SFTY Noted steps were out of level. This is a safety hazard.

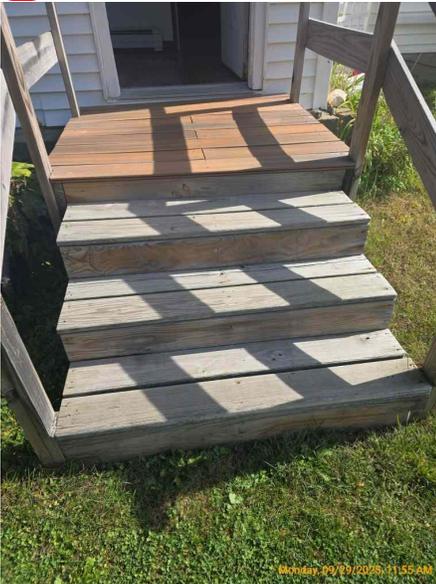
SFTY Steps were a non-standard size or spacing. This is a safety hazard.

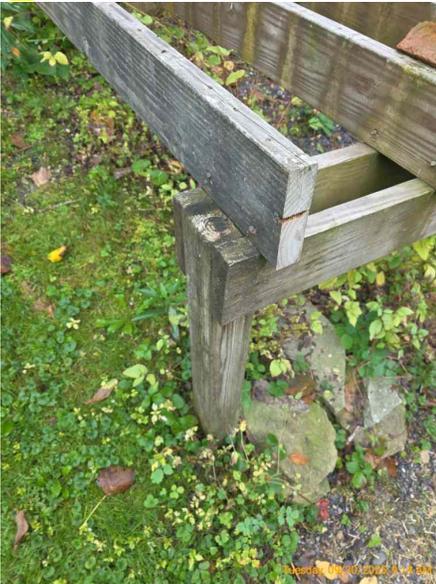
FIX Noted non-standard deck framing. This could compromise the structural integrity of the framing.

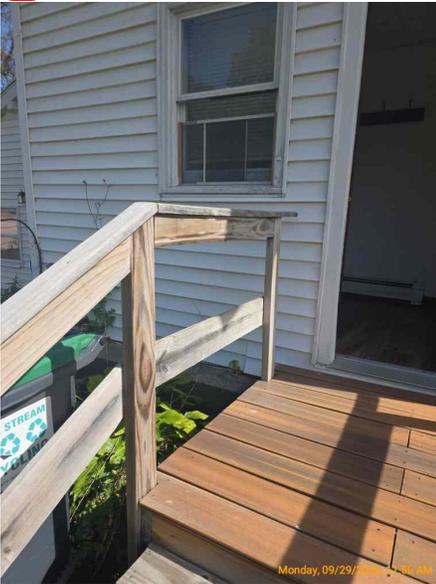
SFTY Guardrail construction is non-standard. This is a safety hazard.

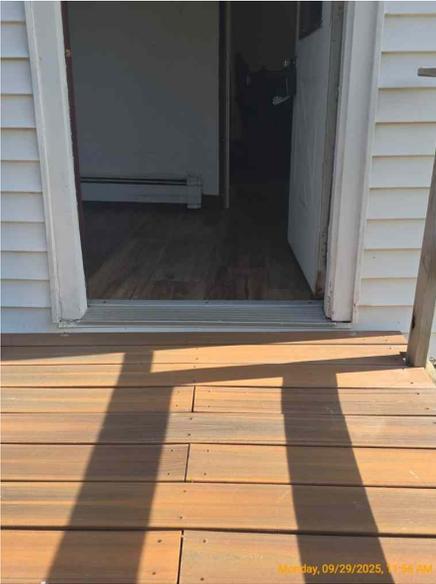
MIN Deck was flush with the exterior door. This could allow for moisture infiltration

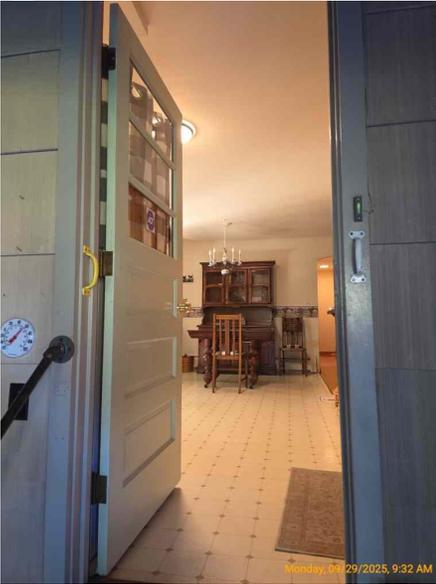
SFTY The garage-house door poses a fire risk because it is not fire-rated.

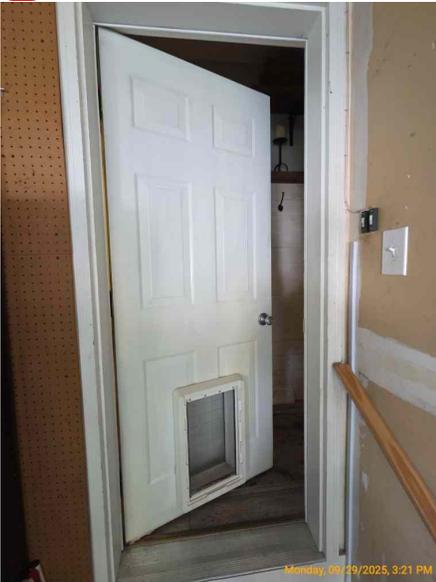
SFTY Garage-house door failed to self close. This is a safety hazard.

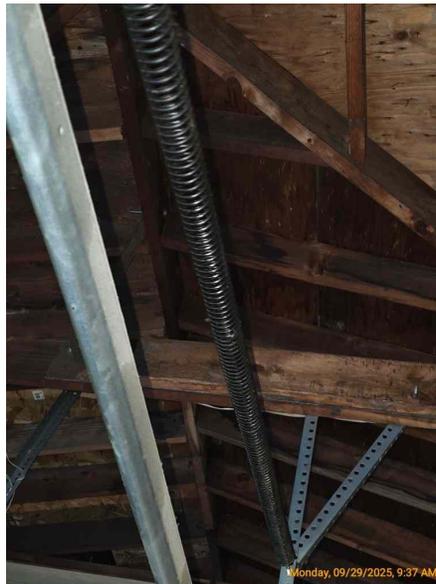
SFTY No safety cable noted on garage door springs. These cables prevent the springs from breaking free in the event of failure. This is a safety hazard.

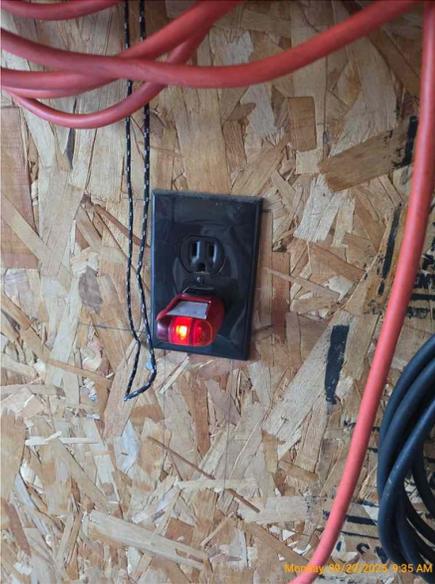
SFTY Noted one or more open ground outlets. This could be a safety hazard when this outlet is used with a three pronged plug. In the even stray electricity is discharged to the unconnected ground electric shock can occur.

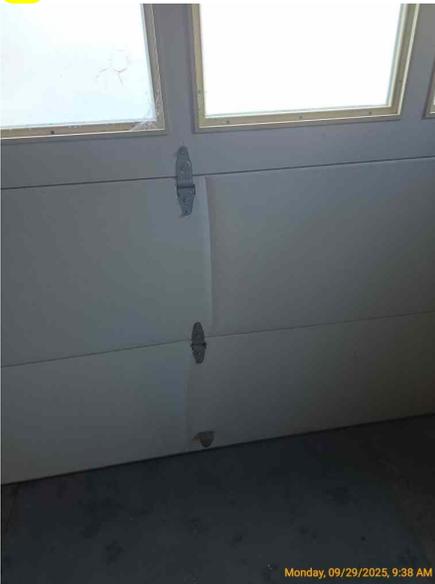
FIX Noted the overhead door was damaged. This could compromise the function of the door.

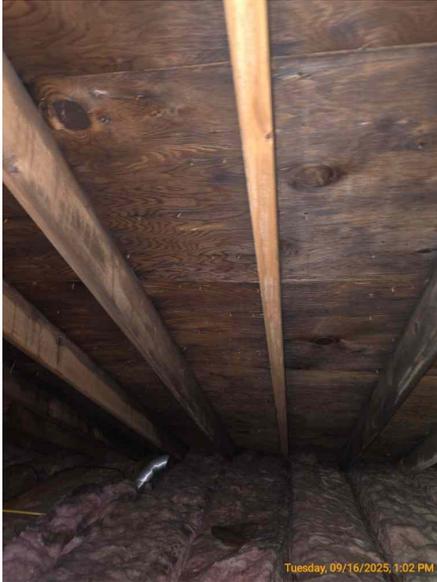
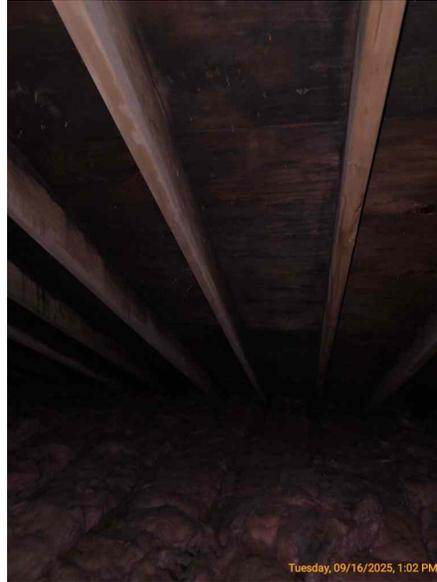
cost Mold like substance was discovered in the attic. Cost to remove will exceed \$2000 and require a mold assessment prior to removal. As agreed Carey Home Inspection will provide an initial Mold Assessment separately from this report. Please contact us to schedule a clearance inspection once removal of the mold takes place.

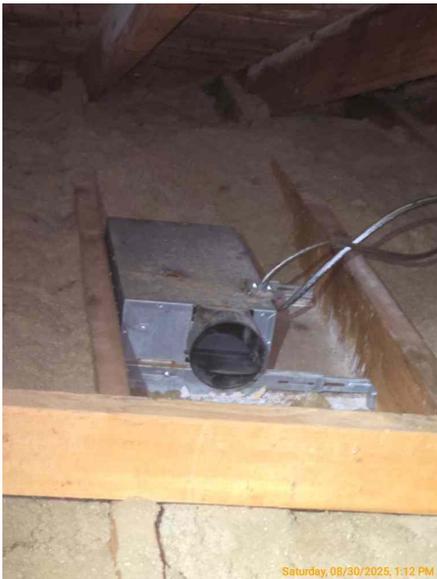
FIX The duct from the bathroom exhaust fan did not go to the exterior. This condition allows excessive moisture to be vented into the attic. We recommend this deficiency be corrected.

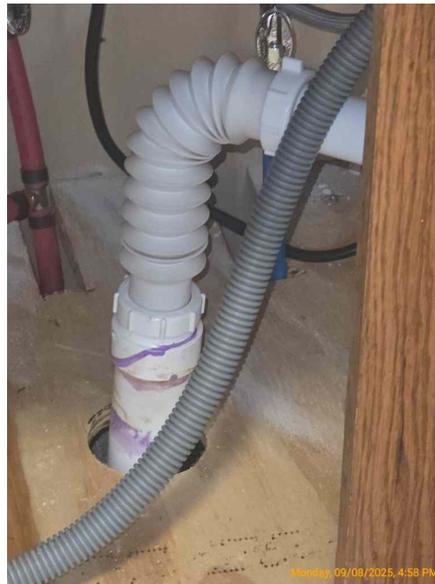
UPGR A flexible rubber or plastic fitting was used in the drain trap and was nonconforming. The system was functional at the time of inspection, modification would be considered optional.

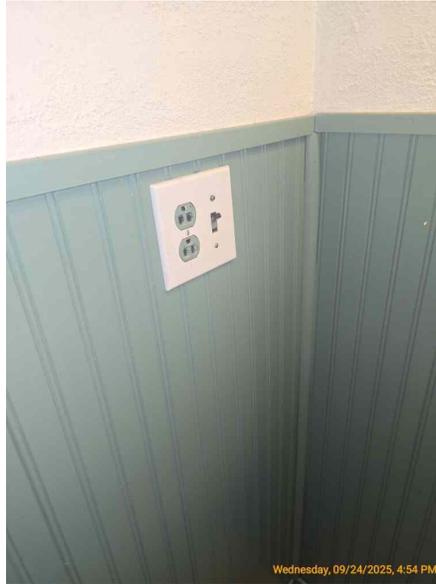
SFTY There was no GFCI (ground fault circuit interrupter) protection noted for this bathroom. For an increased margin of safety, we recommend the installation of a GFCI receptacle.

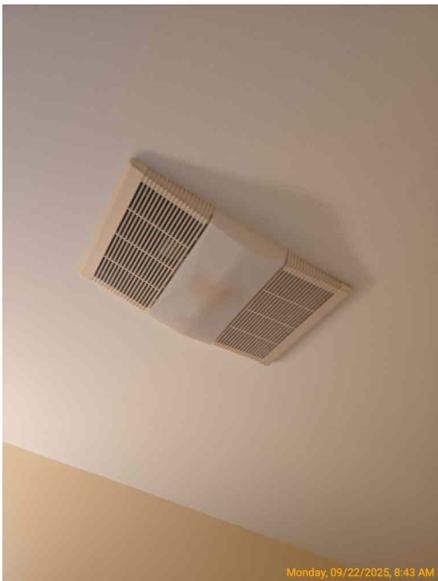
FIX The ventilation fan was not working or has been disconnected. Recommend the fan be repaired or replaced by a qualified contractor.

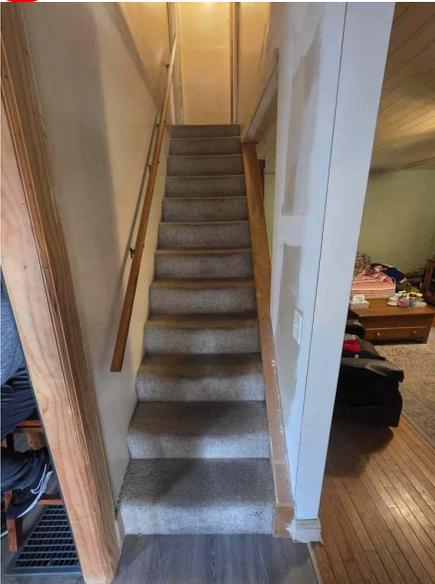
SFTY Steps were a non-standard size or spacing. This is a safety hazard.

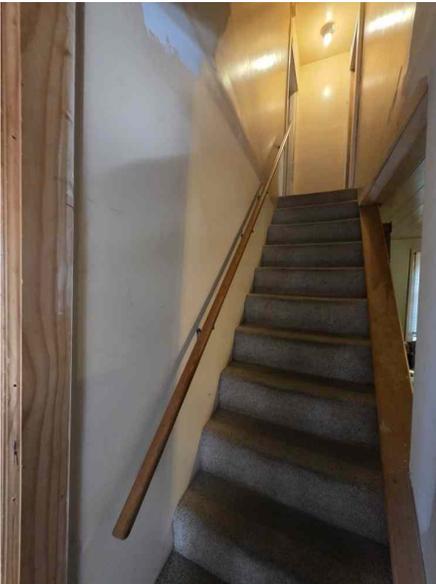
SFTY Noted handrail was non-standard. Handrails should be secured, graspable, and terminate at a wall or post. Handrails must also conform to height standards, which vary between 34 and 38 inches. This is a safety hazard.

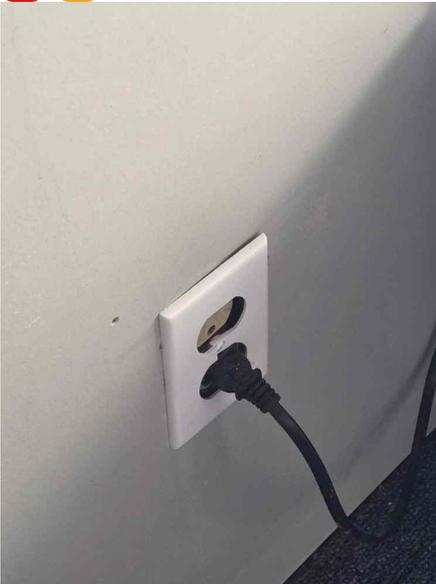
SFTY **MIN** Outlet is damaged. This is a safety hazard.

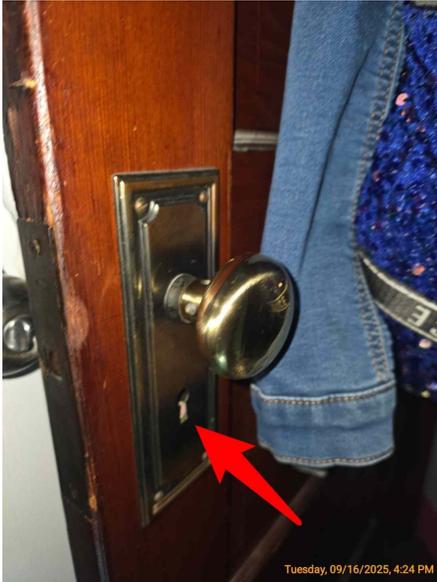
SFTY Noted keyed interior deadbolt locks. This can be a safety hazard in the event of a fire when the key is not available. The door cannot be used as an exit, causing entrapment. Key-only deadbolts should be replaced with deadbolts that have a handle on the inside.

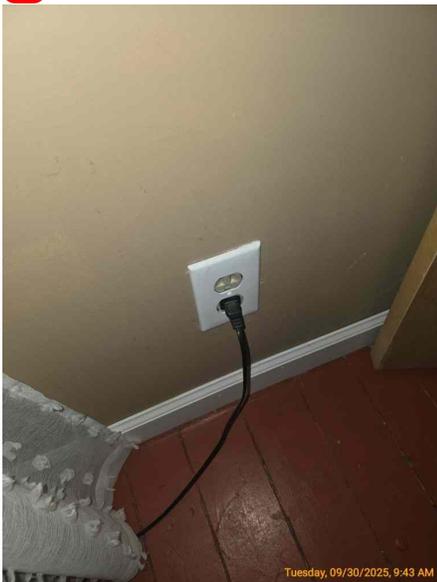
SFTY Outlet was loose. This is a safety hazard.

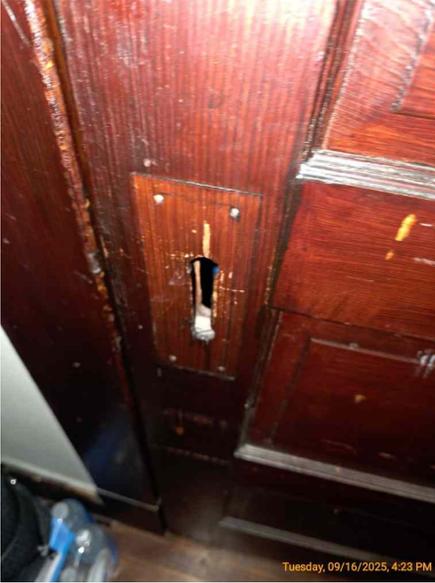
MIN Noted missing or damaged door hardware. This could compromise the function of the door.

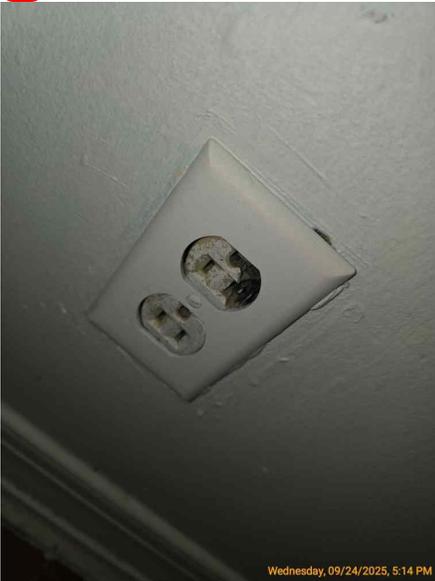
SFTY Outlet was damaged. This is a safety hazard.

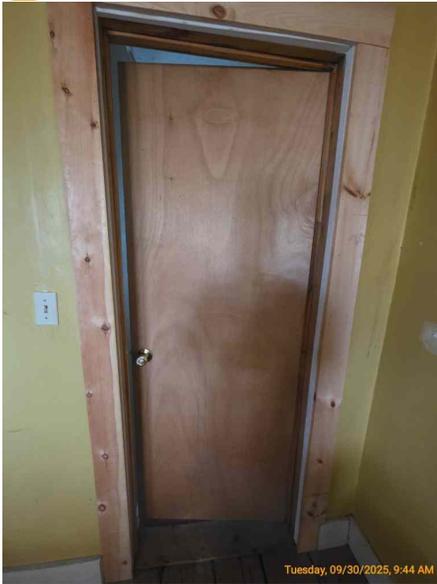
MIN Door was not properly fitted. This could compromise the function of the door.

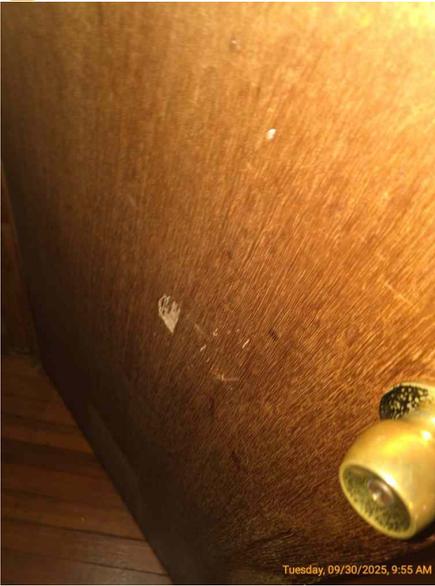
MIN Door was damaged. This could compromise the function of the door.

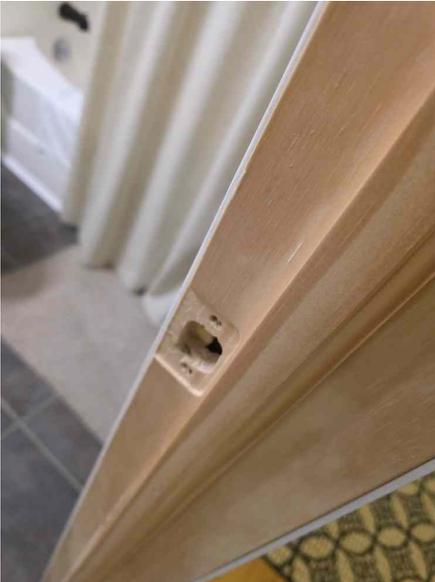
MIN Latch striker was missing. This could compromise the function of the door.

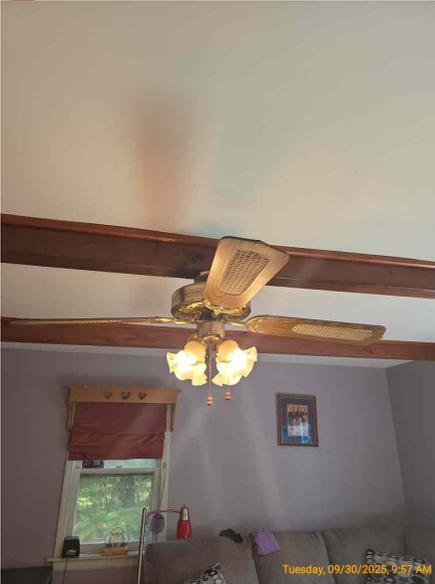
SFTY Ceiling fan is too low. This is a safety hazard.

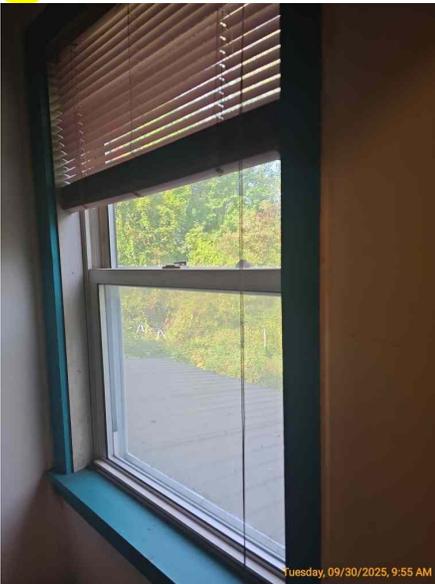
FIX Window would not operate properly.

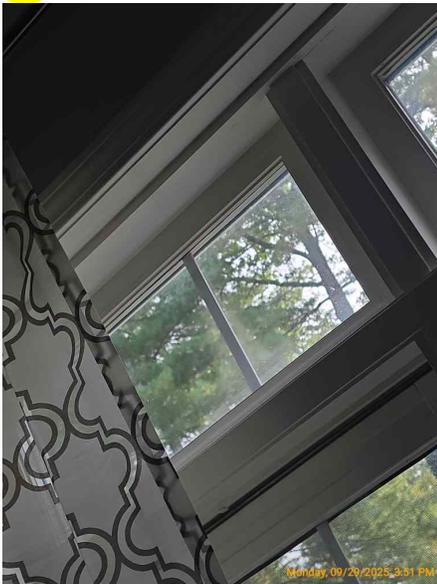
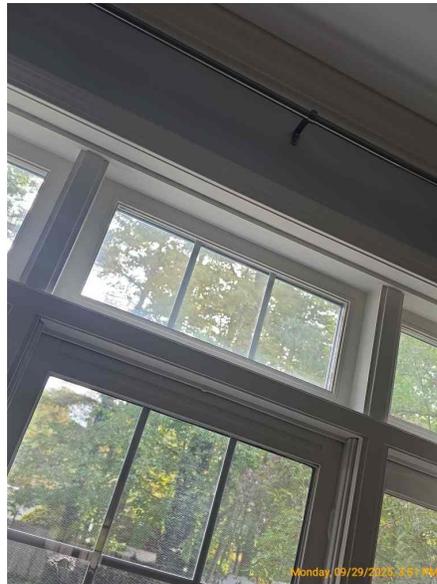
FIX Window appears to have lost its thermal insulation.

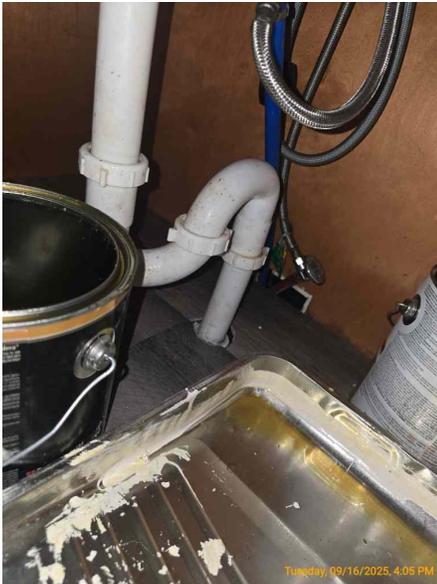
UPGR The drain trap was installed in a nonconforming configuration known as an 'S trap'. Under certain circumstances, this trap could allow venting of sewer gasses into the surrounding area. Modification would be proper and is recommended.

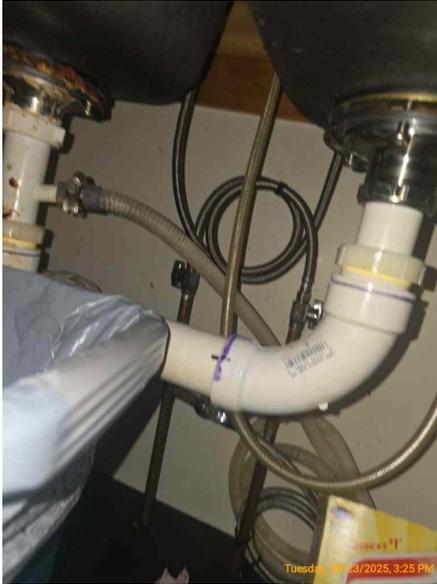
MIN Noted there was no high loop installed on the dishwasher drain. This prevents water standing in the drain or cross connection issues. Recommend repair.

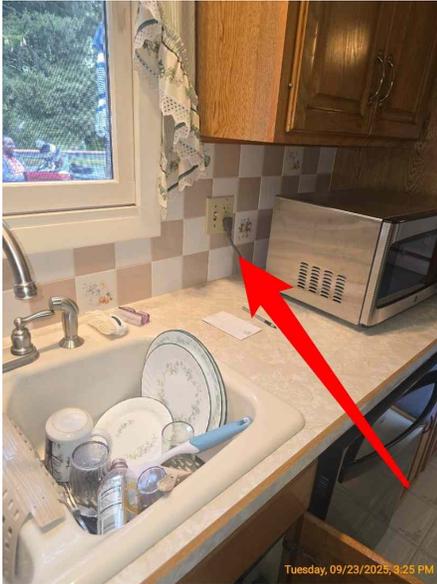
SFTY GFCI protection was not found at all countertop receptacles or those within six feet of a sink. We recommend upgrading in compliance with current standards.

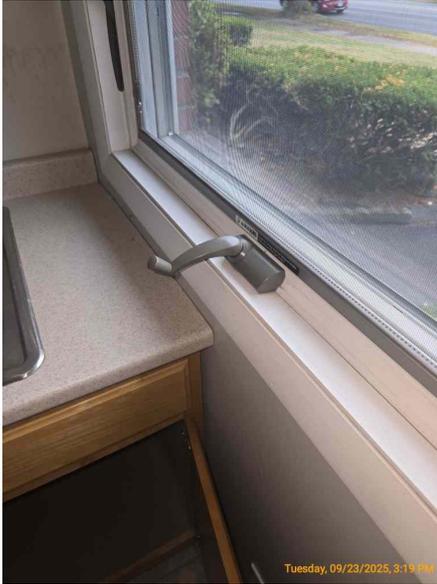
FIX The winding mechanism on one window is defective. We recommend it be replaced to make the window operable.

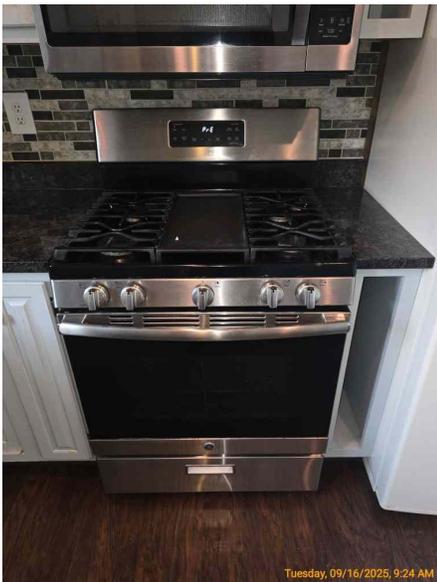
SFTY The oven is not properly attached to the wall or cabinet. We recommend that it be secured using an 'anti-tip device' and/or attached according to the manufacturer's installation instructions.

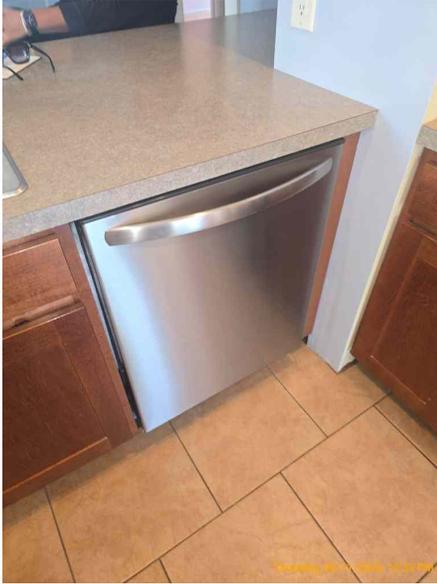
FIX The dishwasher is not properly attached to the cabinets. We recommend it be attached according to the manufacturer's installation instructions.

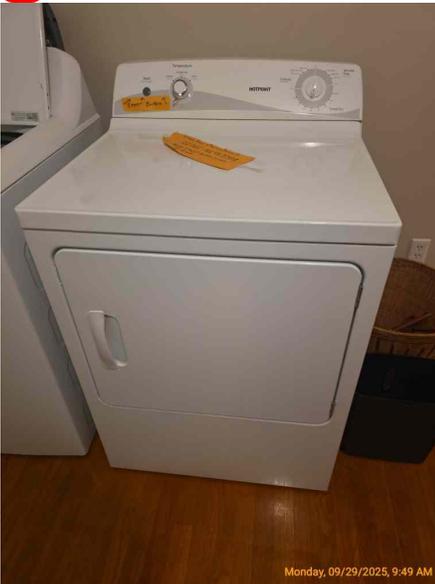
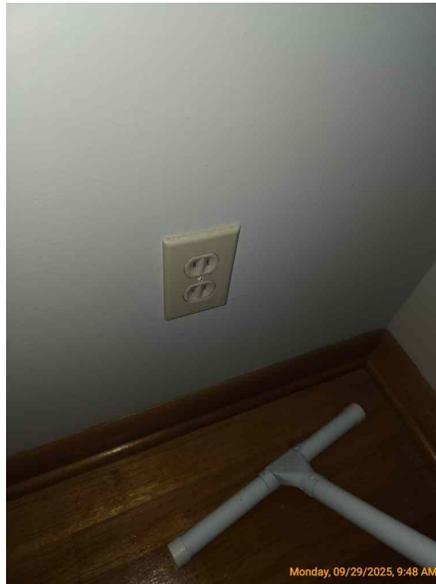
RECEPTACLES

SFTY Laundry area outlet was not GFCI protected. This is a safety hazard.

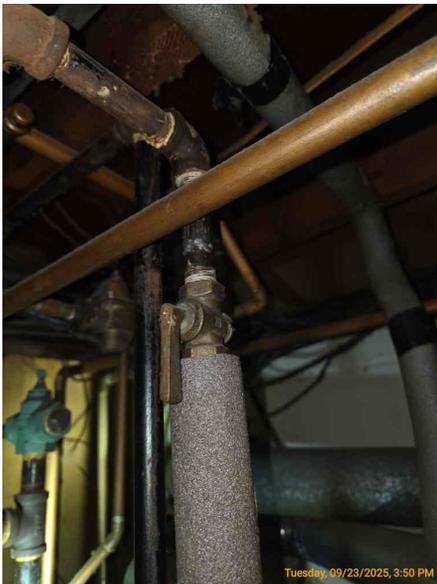
GAS SUPPLY

FIX Noted grease packed gas valve. These are no longer used as they are prone to leaking. No leak was detected at the time of inspection. It is recommended these be replaced with modern ball valves.

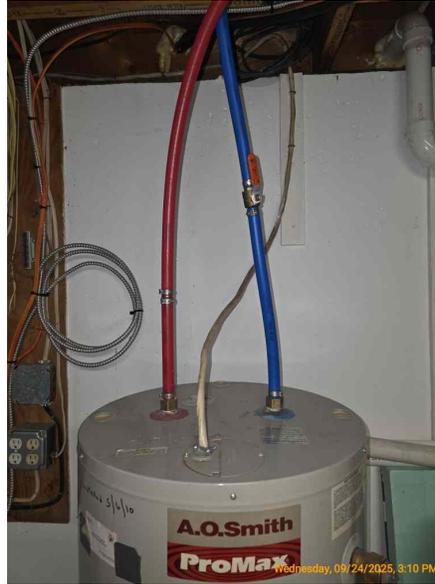
WATER CONNECTORS

MIN Noted plumbing supply connections to the hot water heater are PEX (cross-linked polyethylene) within 18 inches of the tank. PEX is not an acceptable connection material.

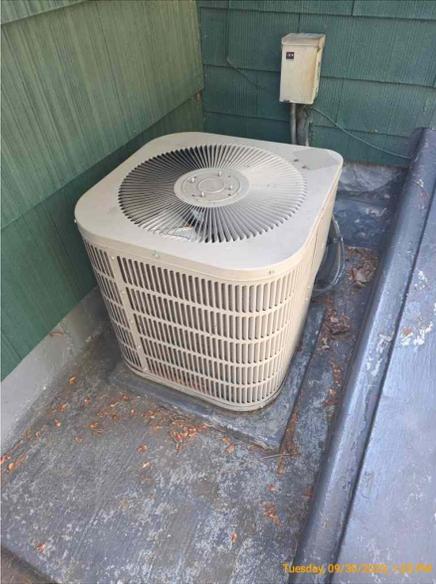
EXTERIOR A/C DEFECTS

MIN The A/C compressor is out of level. This can lead to unbalanced loads for any motors or fans, Possibly causing the premature wear of belts an/or bearings in the compressor motor.

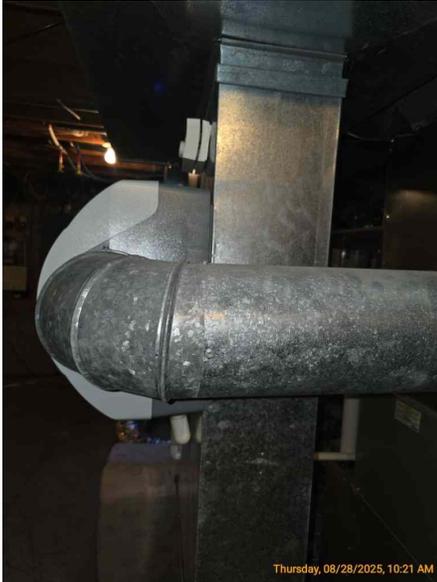
SYSTEM NOTES

MAIN Noted the furnace is equipped with a whole house humidifier. Humidifiers are excluded from inspection. If this unit is turned off we recommend checking for leaks when turned on. We do not turn on shut down humidifiers. Whole house humidifiers should be cleaned according to the manufacturer's recommended schedule. Furnace mounted humidifiers have a life of about ten year. Old humidifiers should be updated or removed.

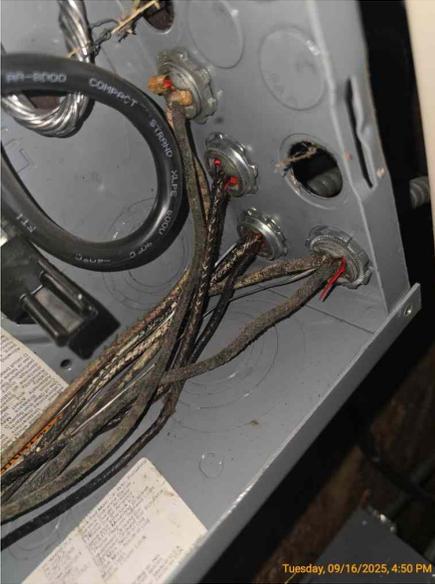
CB MAIN PANEL

SFTY There are holes in the service panel where 'knockouts' have been removed and left open. This is not an approved practice and we recommend the holes be closed with approved filler plates.

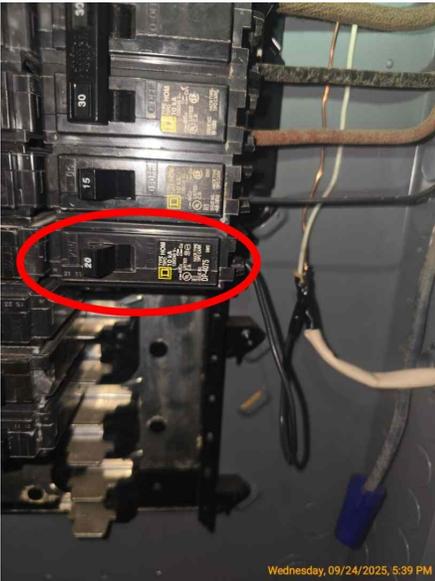
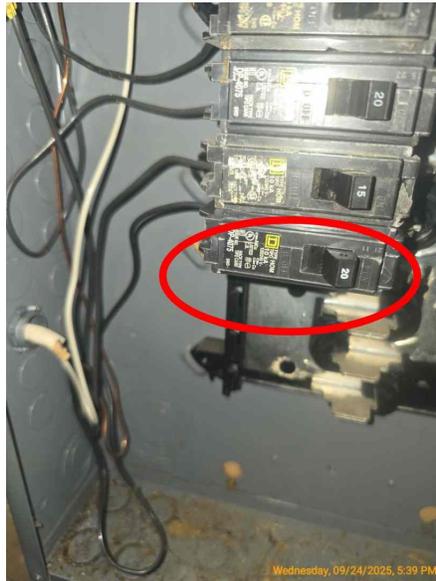
MAIN CIRCUITRY

SFTY We found over-fusing in the main service panel, meaning breakers or fuses are not rated for their connected wires. This is a potential fire hazard. We recommend circuits be equipped with properly rated overcurrent protection devices.

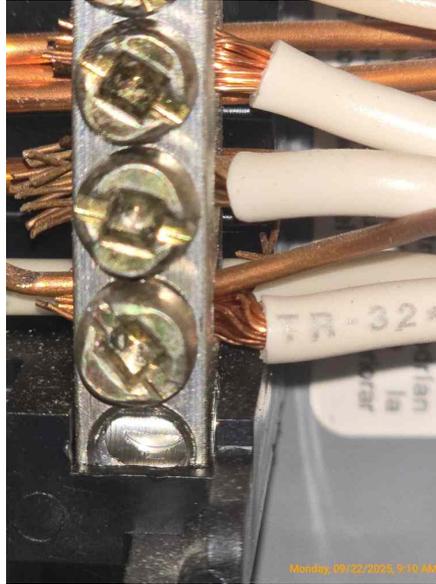
MIN One or more neutrals are double tapped, where 2 or more white wires are clamped in one terminal or a white and ground wire are in the same terminal. This method of wiring is common but no longer acceptable. It is not acceptable to have the neutral connection and the ground connection under the same screw since disconnecting the neutral would also disconnect the ground. The intent is that the ground, including the grounding electrode connection, always remain solidly connected. Recommend having a licensed electrician evaluate and repair.

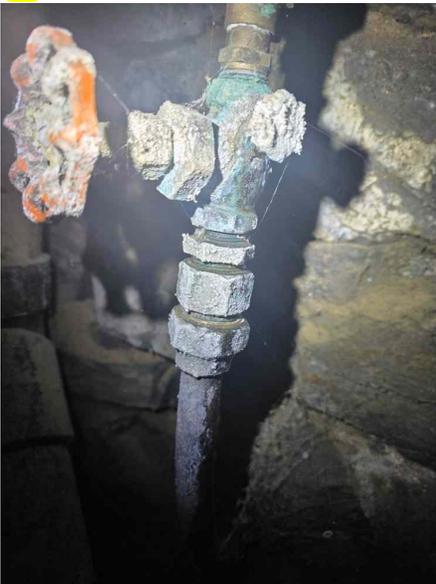
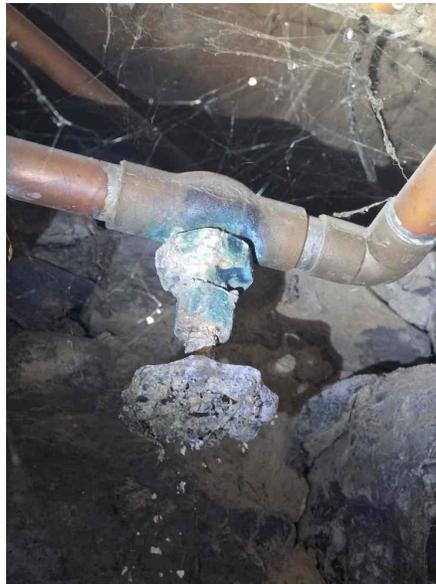
INTERIOR SUPPLY

FIX Noted active leak in supply pipes or fittings at the time of inspection.

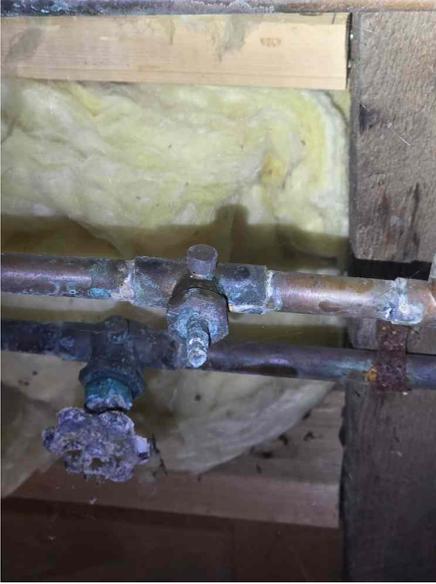
MIN Noted missing valve handle.
