Confidential Inspection Report

LOCATED AT:
123 Main Street
Somewhere, New York 12018

INSPECTED ON:
Thursday, October 30, 2025

Carey Home Inspection

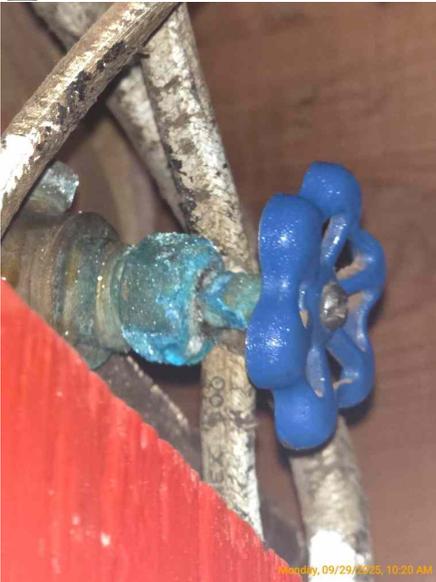
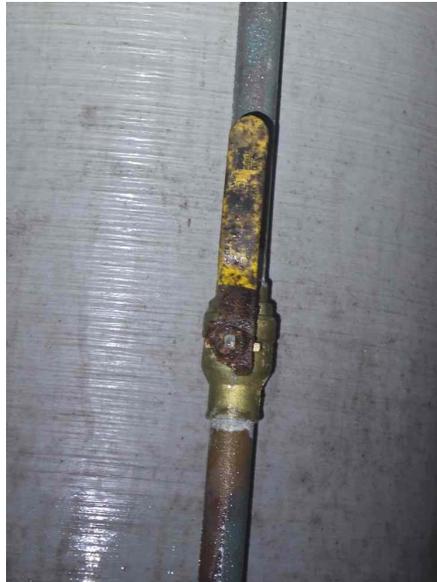
MON Noted areas of excessive corrosion on pipes or fittings. Recommend monitoring these pipes for leaks.

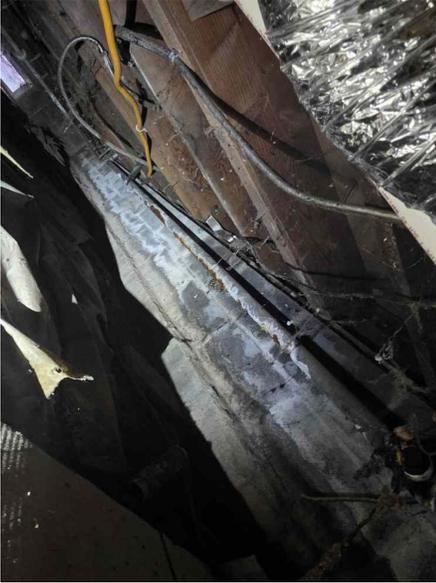
DRAIN LINES

FIX Noted active leak in drain and/or waste pipes or fittings at the time of inspection.

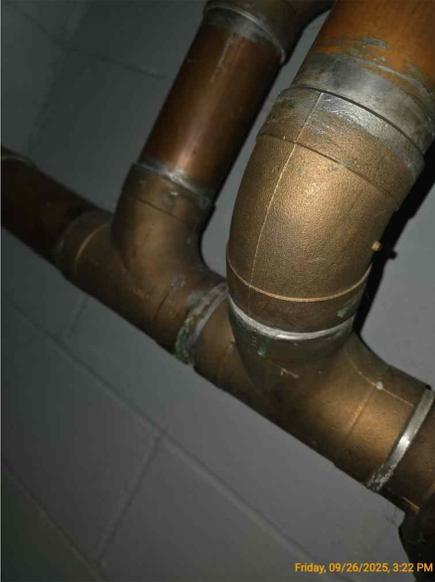
MIN Noted a sanitary tee was used where a plumbing wye should be used. Sanitary tees can not be used in a horizontal position because the drain can flow in the wrong direction.

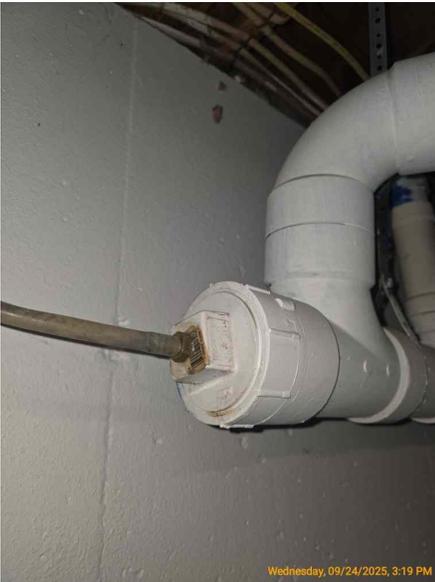
CLEANOUT

FIX Noted plumbing clean out used as a drain. This is not an acceptable method for draining waste or grey water. Clean outs should be readily accessible.

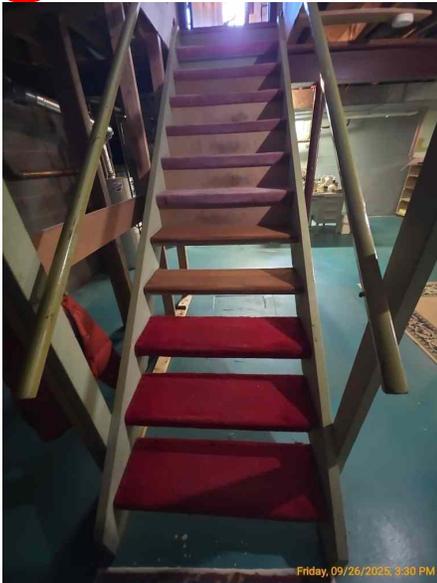
ACCESS DEFECTS

SFTY The basement steps were out of level. This is a safety hazard.

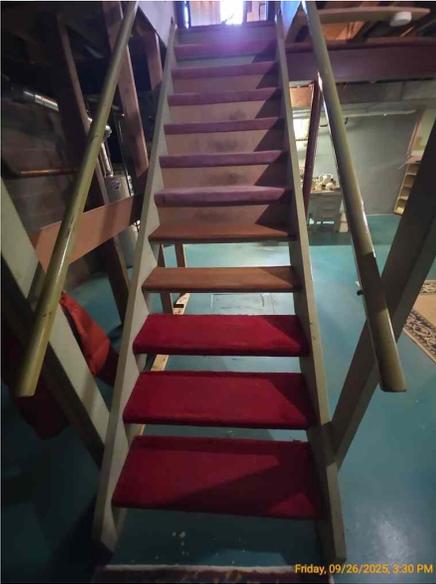
SFTY Steps are a non-standard size or spacing. This is a safety hazard.

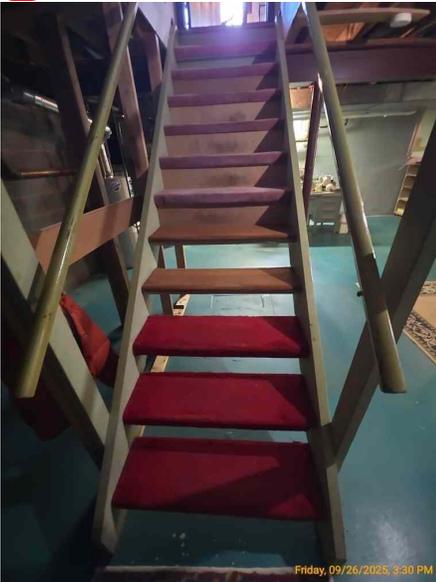
SFTY Solid tread risers were missing. This is a safety hazard.

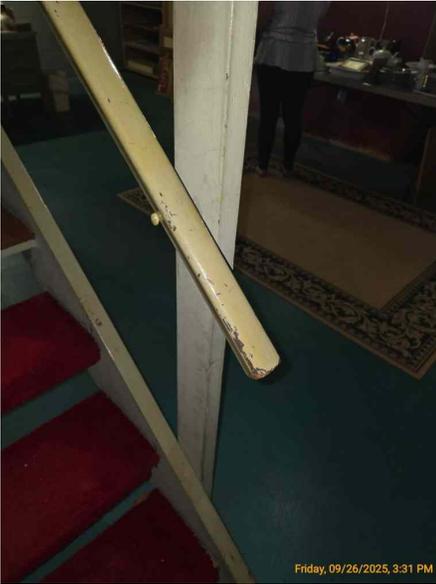
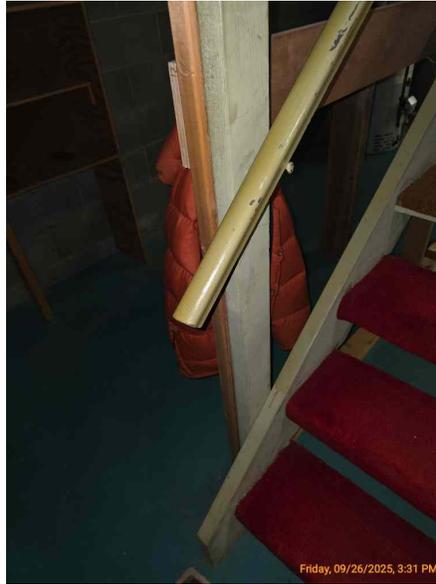
SFTY Handrail was non-standard. This is a safety hazard.

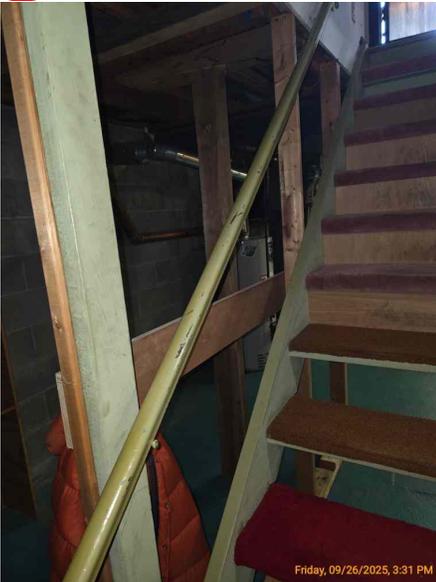
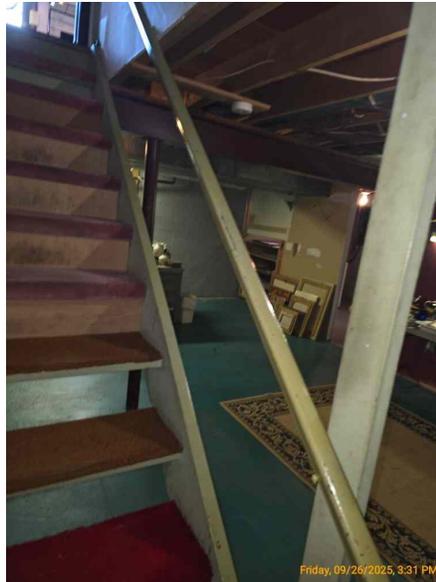
SFTY Noted missing guardrail on basement steps. This is a safety hazard.

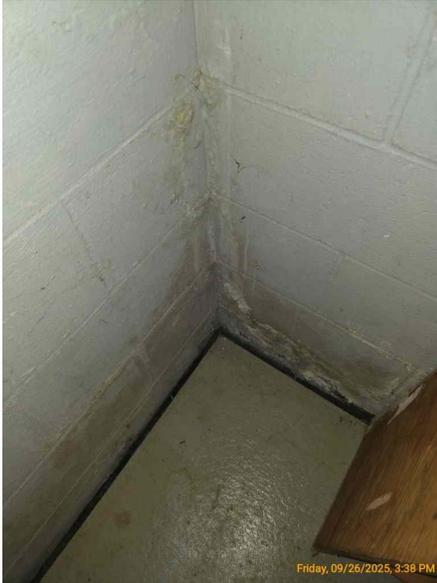
FOUNDATION DEFECTS

Noted efflorescence on foundation walls. This is due to minerals being pulled through the concrete by water. This is typical for masonry walls. Improvements to the gutter system and drainage can help mitigate efflorescence.

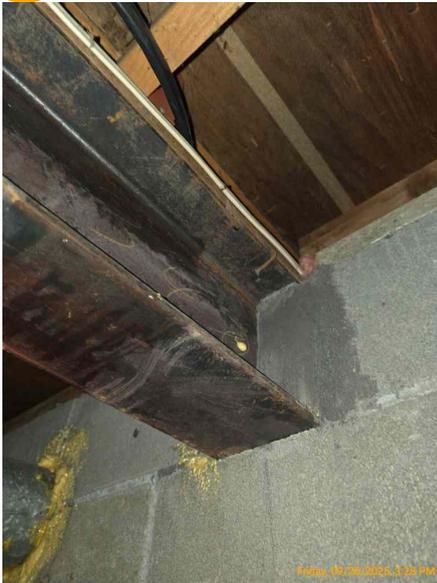
FRAMING AND SUBFLOOR DEFECTS

MIN Beam lacks proper air gap at the foundation wall. This could allow for deterioration of the beam.

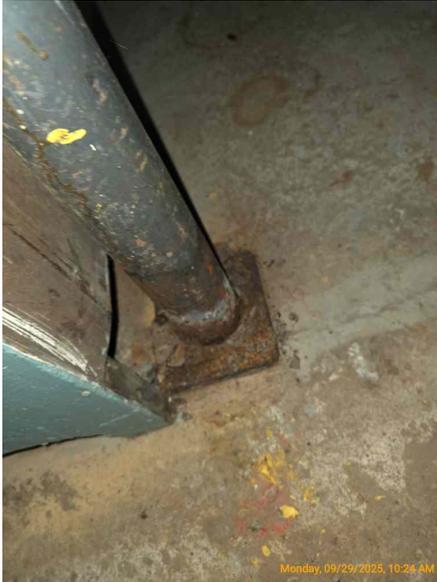
SUPPORT POST DEFECTS

FIX Noted rusted beam supports. If left as is further deterioration could occur. This could compromise the structural integrity of the supports.

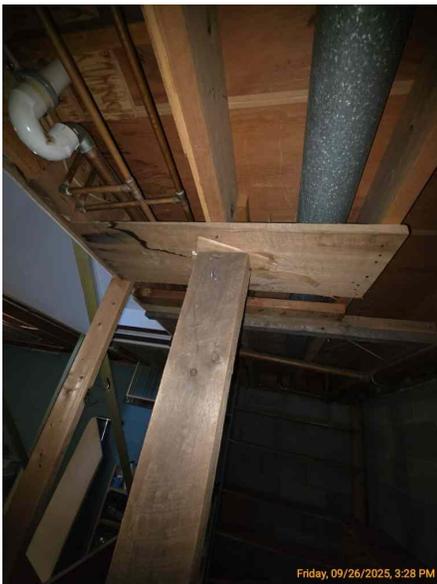
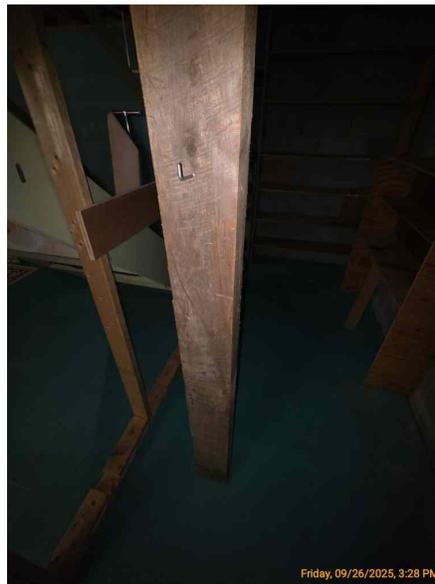
FIX Noted non-standard supports. This could compromise the structural integrity of the support and the floor structure above.

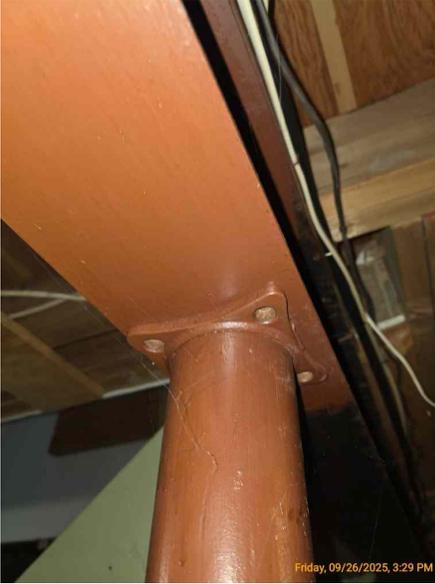
MIN Supports are not properly attached to the beam. This could compromise the structural integrity of the supports.

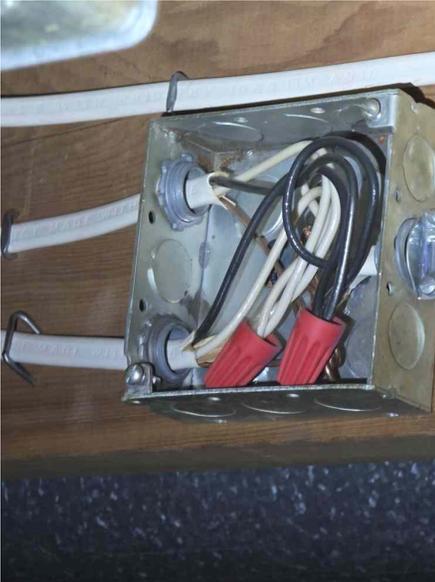
ELECTRICAL DEFECTS

SFTY Noted exposed electrical wiring. This is a safety hazard.

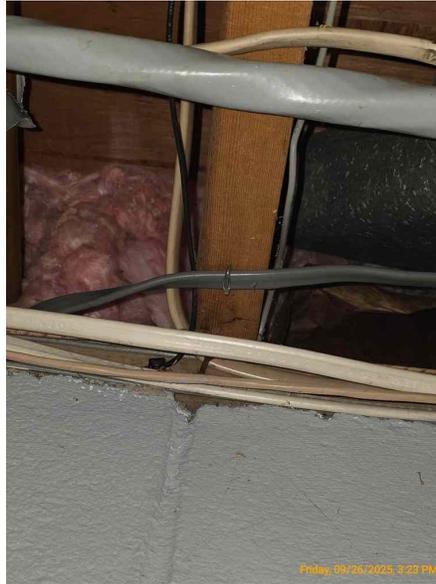
SFTY Electrical wiring was installed incorrectly. Non-metallic wiring should be installed in such a manner that it is not prone to damage. This is a safety hazard.

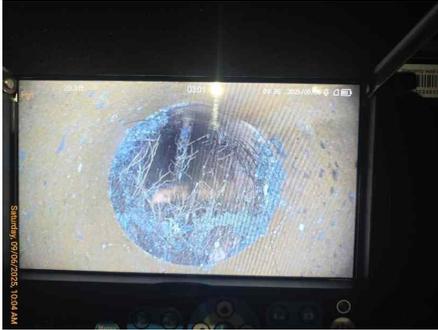
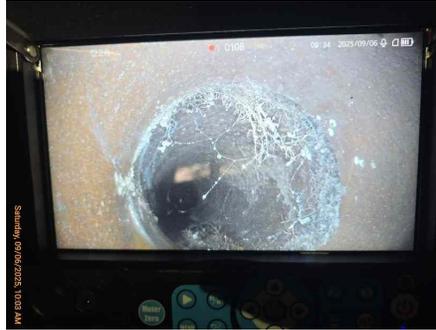
FIX Noted roots in the drain system. Roots are a common maintenance problem with many drain systems. Recommend a qualified dream cleaner be hired to remove the roots and clean the drain.

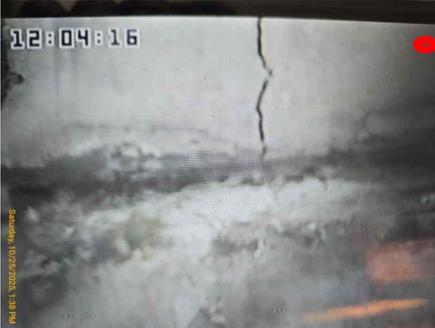
FIX Flue liner in the chimney has softened, cracked, or otherwise deteriorated so that it no longer has the continued ability to contain the products of combustion, (i.e., heat, moisture, creosote, and flue gases), the liner shall be either removed and replaced, repaired, or relined with a listed liner system or other approved material that will resist corrosion, softening, or cracking from flue gases at temperatures appropriate to the class of chimney service. This repair should be performed by a qualified chimney liner professional.
